Geomorphological Report, Tributary of Spring Creek

Municipal Class Environmental Study for Clark Boulevard Extension and Eastern Avenue Improvements from Rutherford Road to Kennedy Road

City of Brampton

December 17, 2021
Project No. PN19055

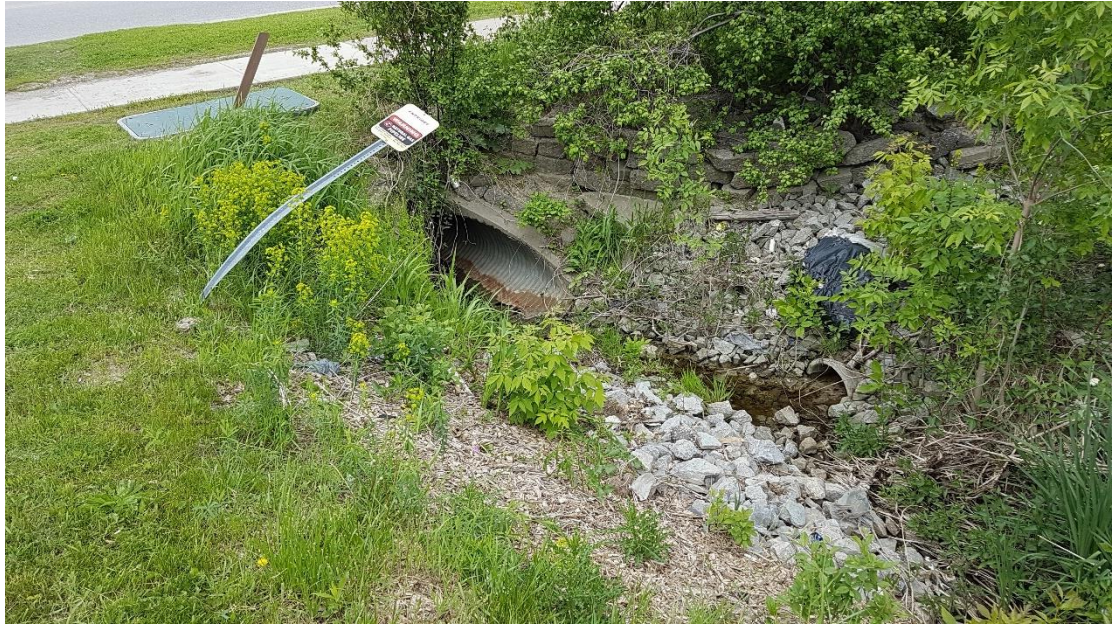
Photo 1

The reach upstream of Hansen Road South was piped underground. The channel resurfaced briefly before entering a 1.4 m CSP culvert.

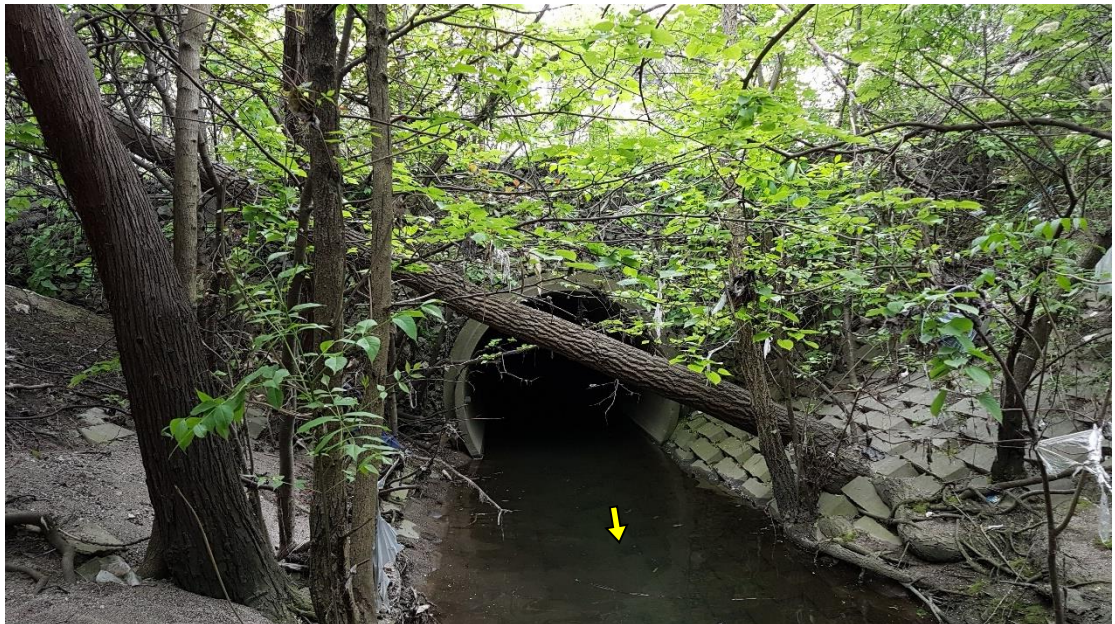
Photo 2

There was additional flow contributions from adjoining subsurface pipes beneath Hansen Road. The collective flows outlet through a 2.1 m concrete culvert encased within a gabion basket retaining wall.

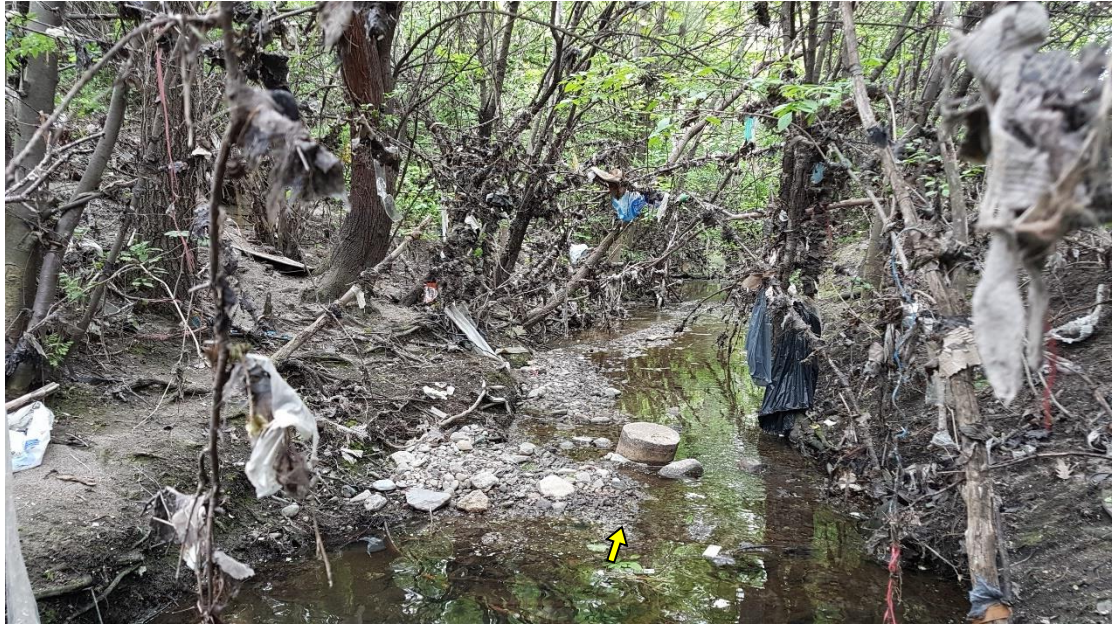
Photo 3

The channel and overbank was laden with debris to heights of ~ 2 m, which was indicative of anticipated high flow conditions.

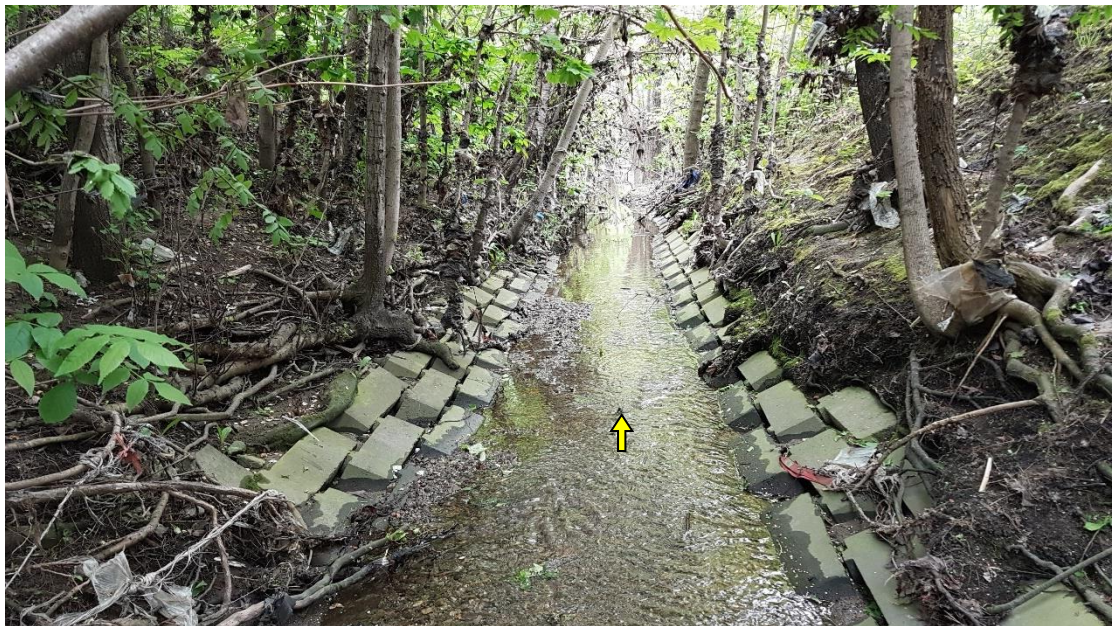
Photo 4

The entire length of channel and bank toe was underlain with an interlocking brick treatment, which had failed (e.g., dislodged) at multiple instances throughout the reach.

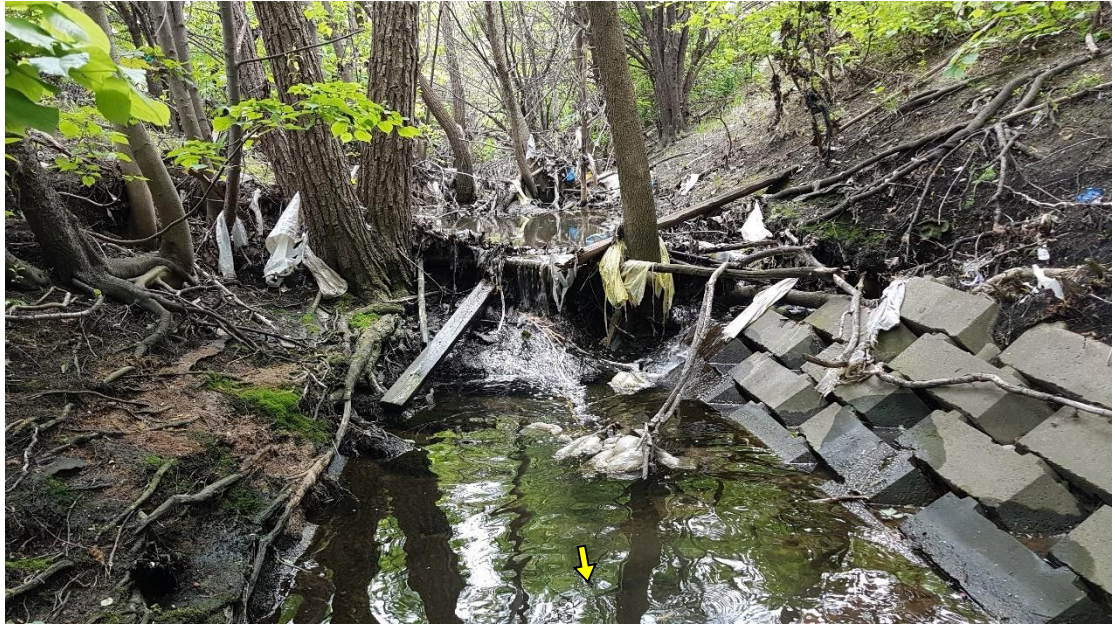
Photo 5

Multiple debris jams were observed throughout the subject reaches, leading to significant aggradation and burial of the brick treatment upstream.

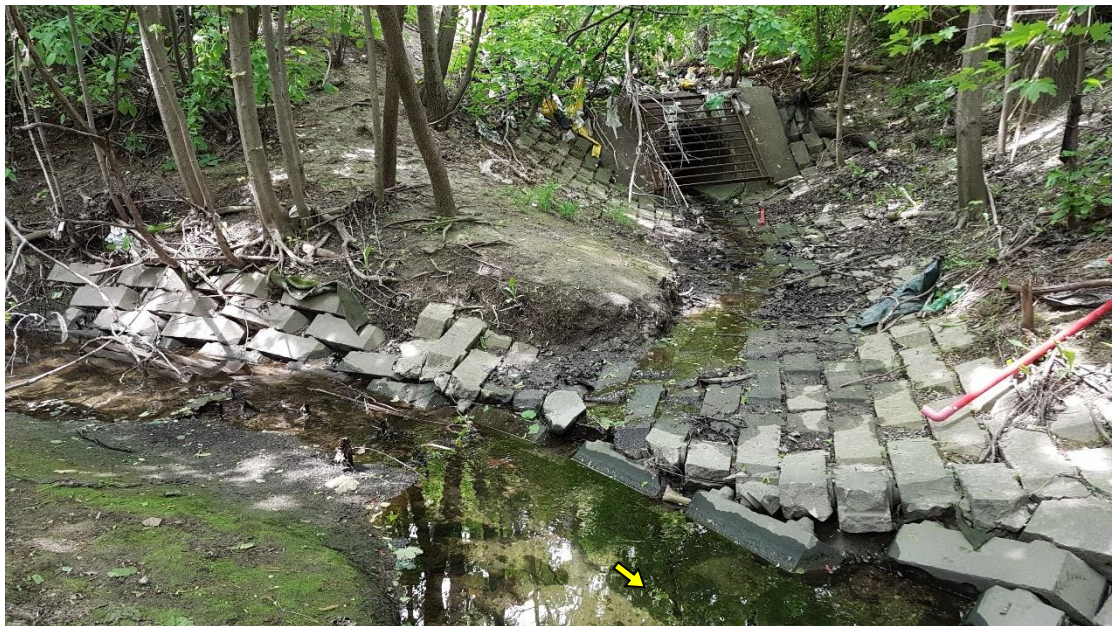
Photo 6

There was a sharp bend in the channel 200 m downstream of Hansen Road, where an adjoining outfall contributed minor flows.

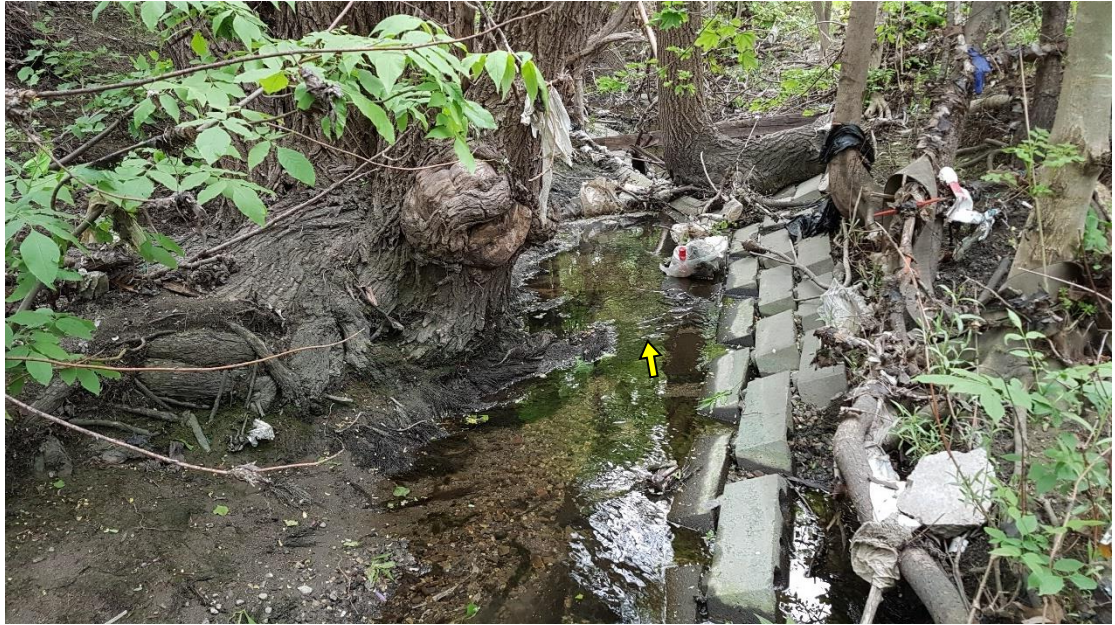
Photo 7

Mature trees had grown over the brickwork and provided indication of the dated nature of the protective treatment.

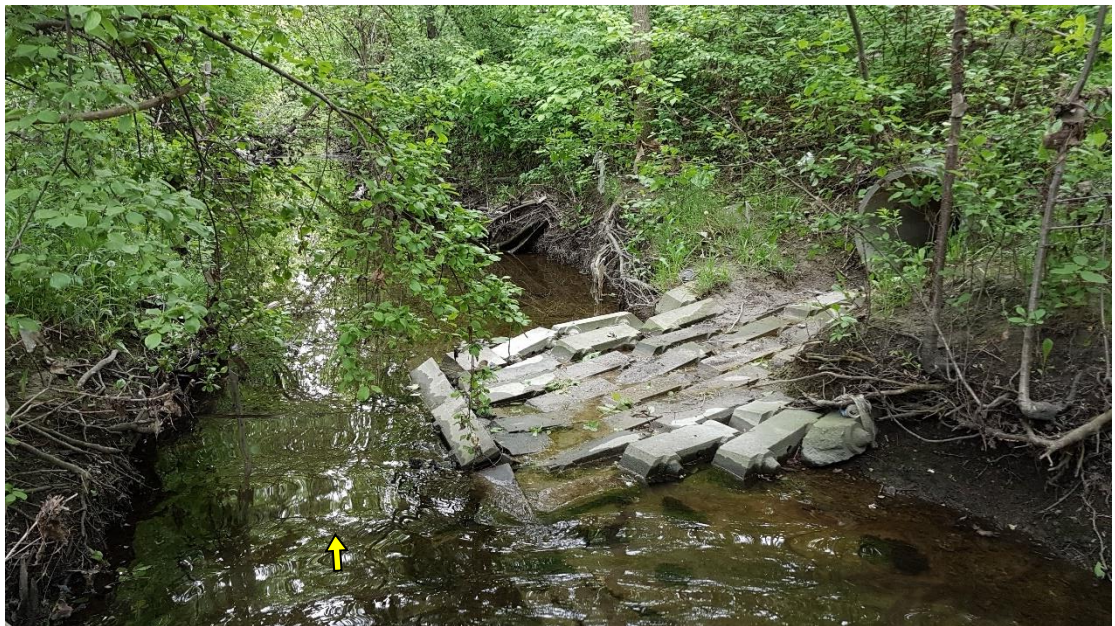
Photo 8

Multiple outlets stemming from adjacent lots fed into the channel from both banks throughout the subject reaches.

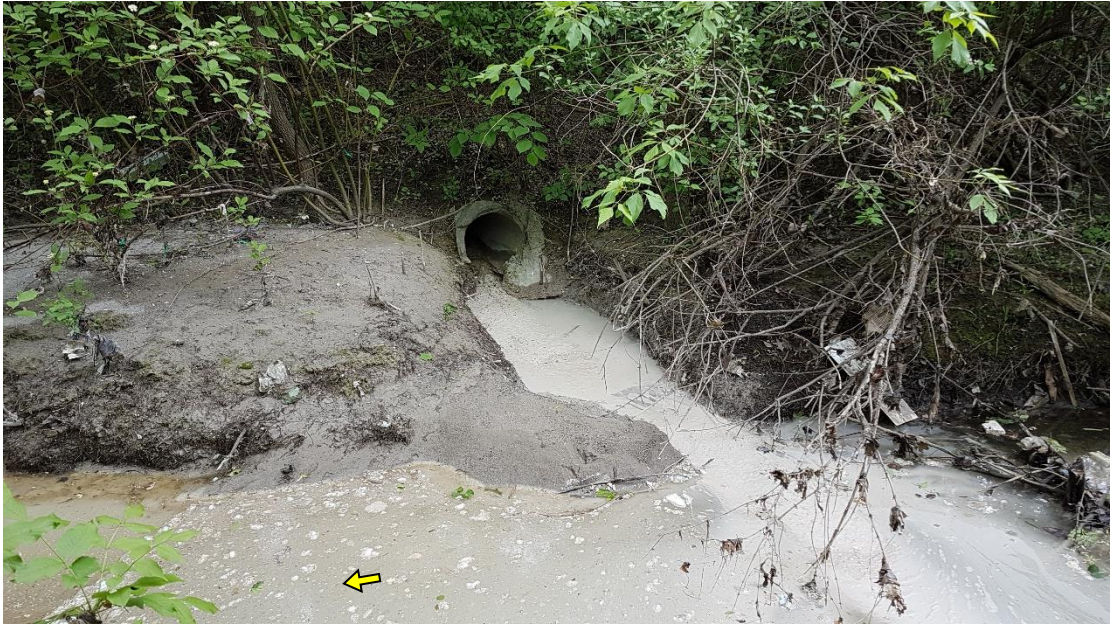
Photo 9

An outlet along the south bank near Rutherford Road discharged a slurry of unknown substance into the creek.

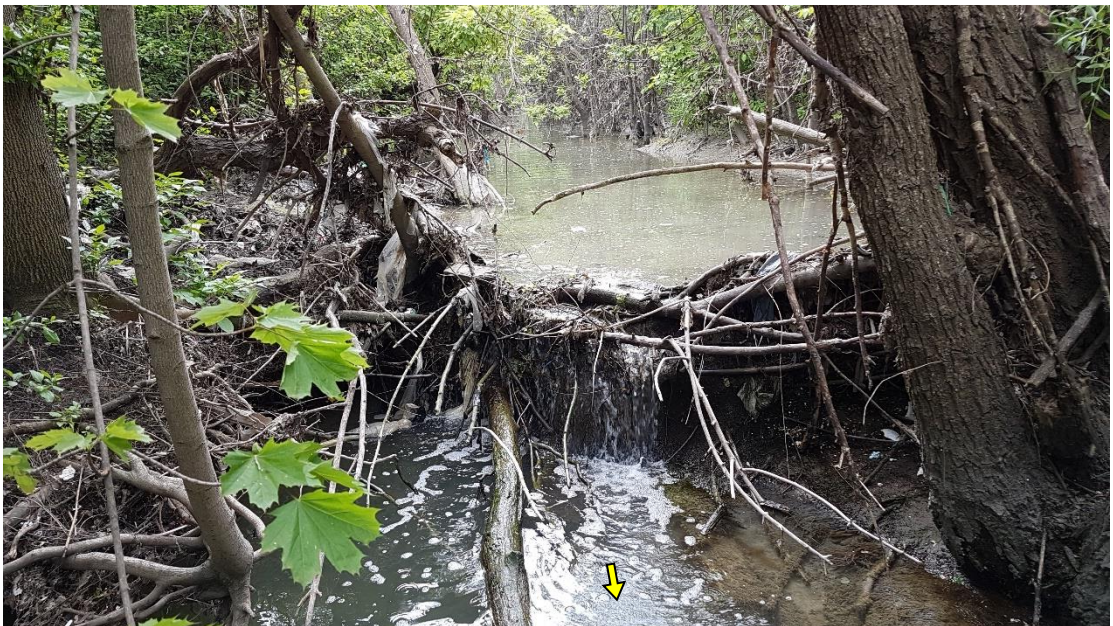
Photo 10

The lightly coloured slurry extended 25 m downstream where it was filtered through a woody debris jam.

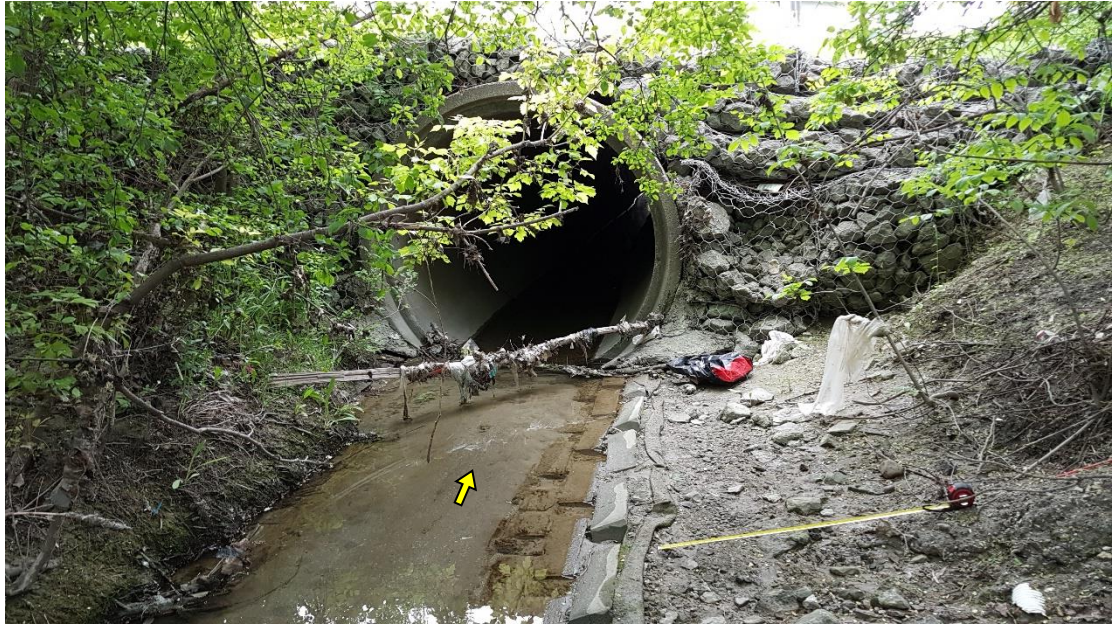
Photo 11

The Rutherford Road crossing consisted of a 1.9 m concrete culvert enveloped in slumping gabion basket. Downstream of Rutherford Road, the culvert was joined by two others, which fed into an oversized pool. All three culverts were perched. The channel reach downstream of Rutherford Road followed a step-pool morphology. Aerial imagery revealed the reach was realigned in 2016. The “steps” were armourstone-based and were separated by overwidened pools. The first armourstone step was relatively elevated, limiting fish passage upstream.

The Rutherford Road crossing consisted of a 1.9 m concrete culvert flanked by slumped gabion basket retaining walls.

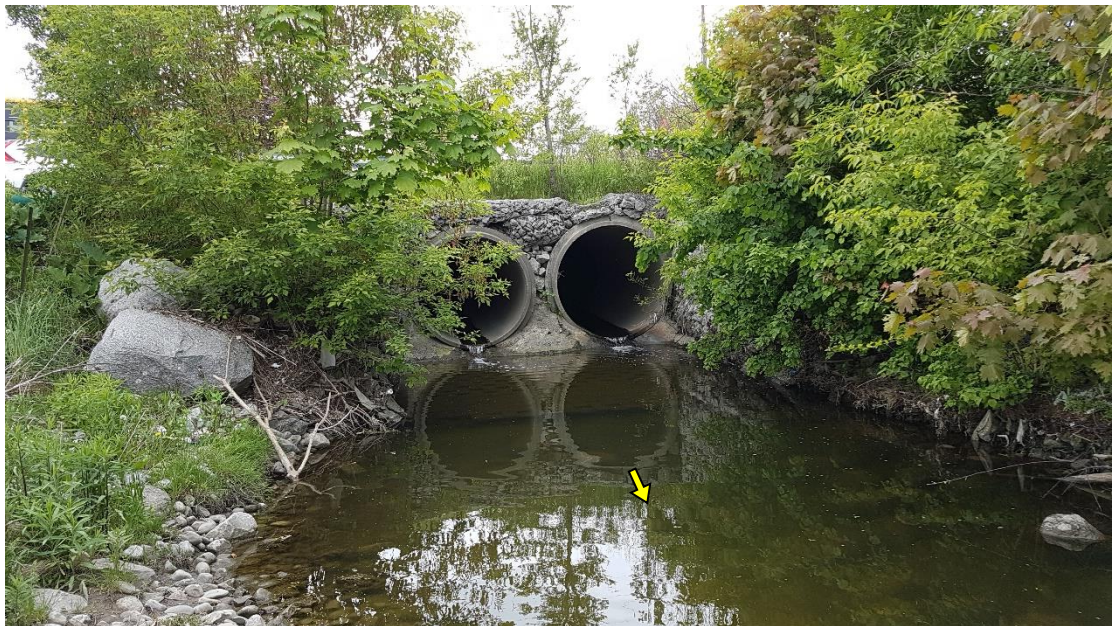
Photo 12

Three perched concrete culverts discharged to the creek downstream of Rutherford Road. The adjoining culverts likely conveyed subsurface storm water drainage from adjacent lots / roadways.

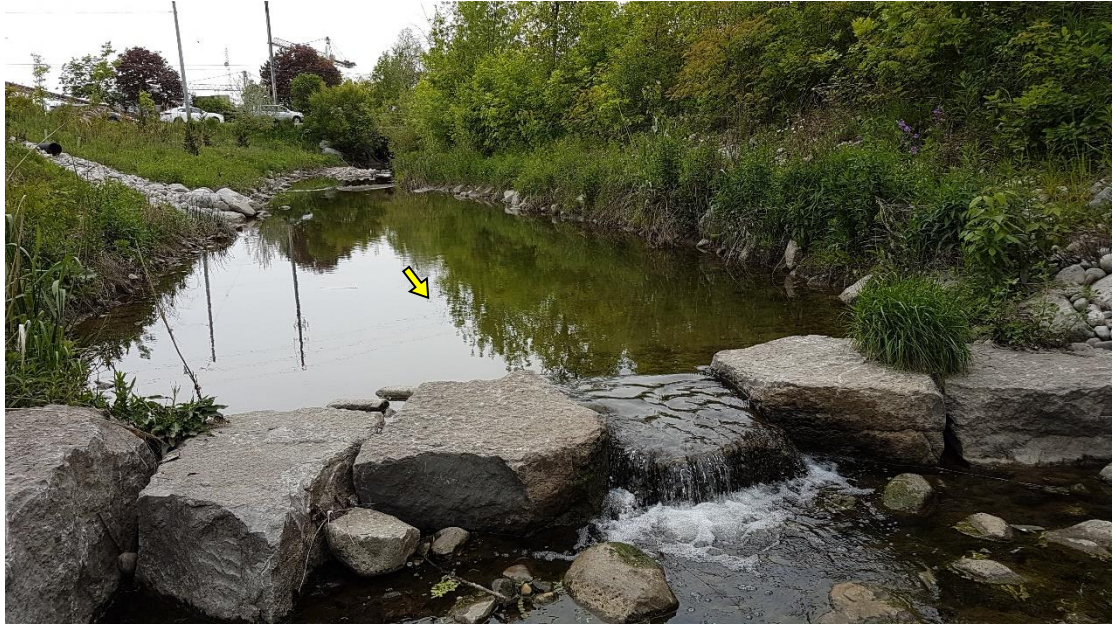
Photo 13

A particularly raised armoursone weir located 65 m from Rutherford Road partially impounded flows and restricted fish passage.

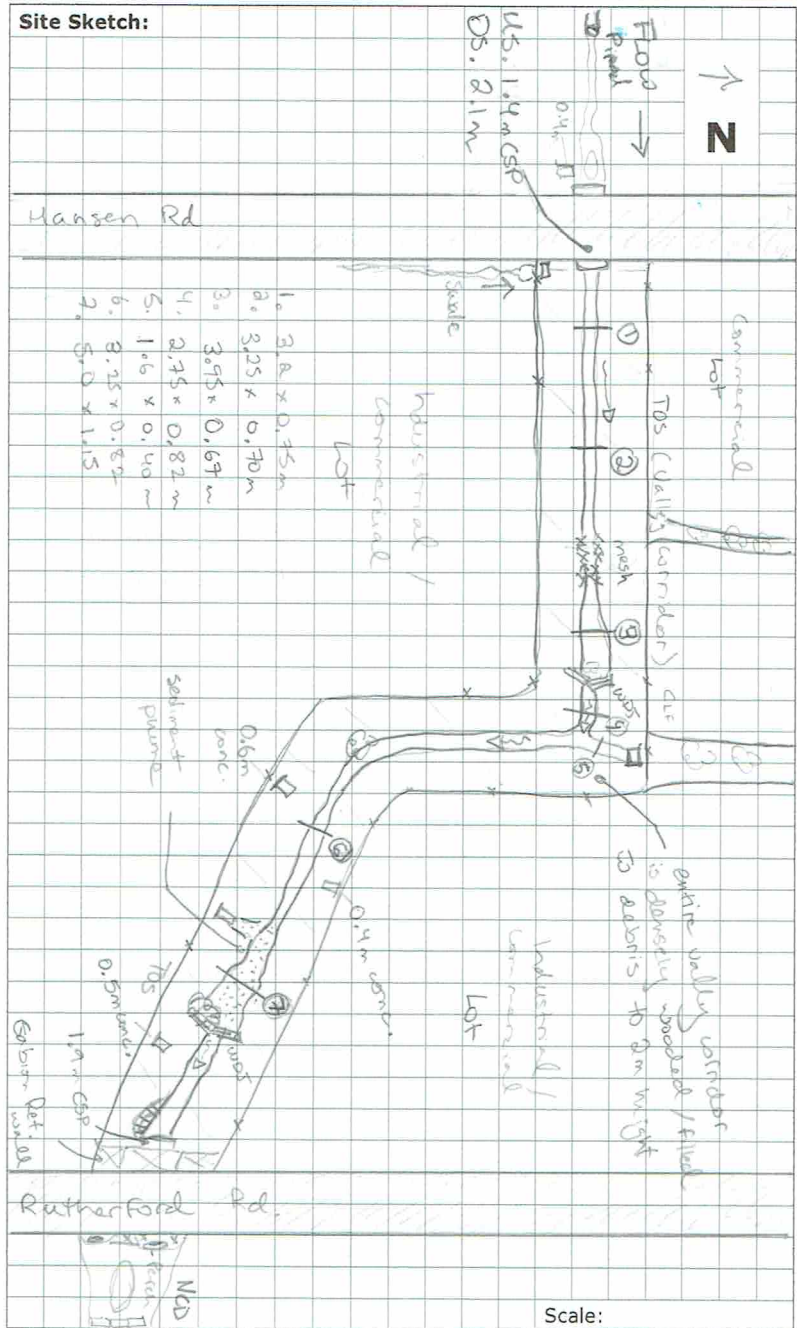
Additional Notes: Full feature lined w brick (bed banks) and occasional wire meshing. The materials are eroded/outflanked. WDJ's cause sedimentation U/S, buying reinforced materials.
