**ENVIRONMENTAL ASSESSMENT STUDY OF ARTERIAL ROADS WITHIN
HIGHWAY 427 INDUSTRIAL SECONDARY PLAN AREA (AREA 47) - PART B
CITY OF BRAMPTON
FLUVIAL GEOMORPHIC COMPONENT**

Prepared by:
MATRIX SOLUTIONS INC.

Version 1.0
November 2022
Mississauga, Ontario

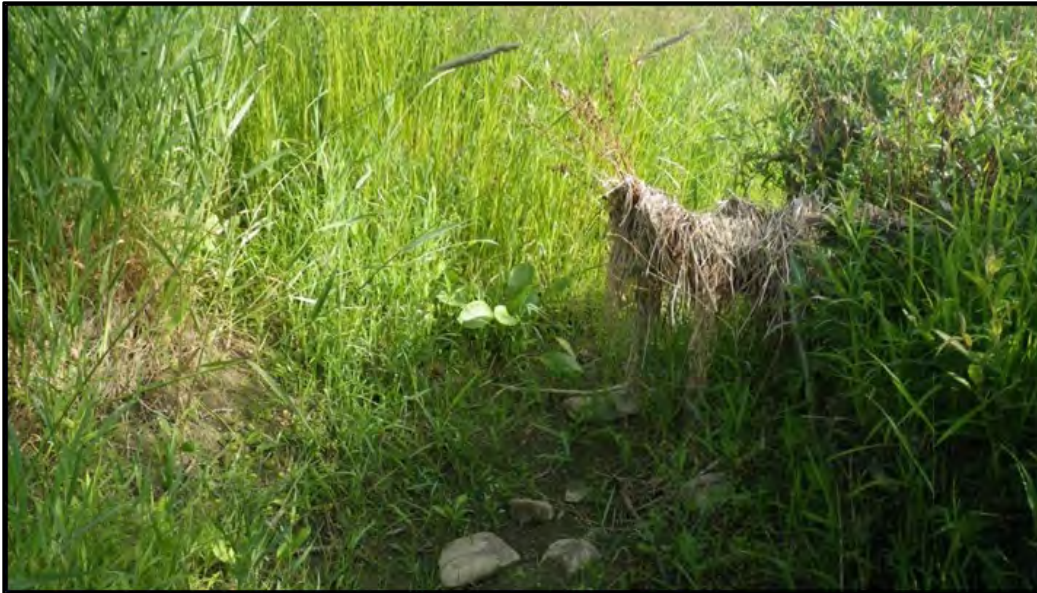
1. Reach G-1D: evidence of high flow above bed

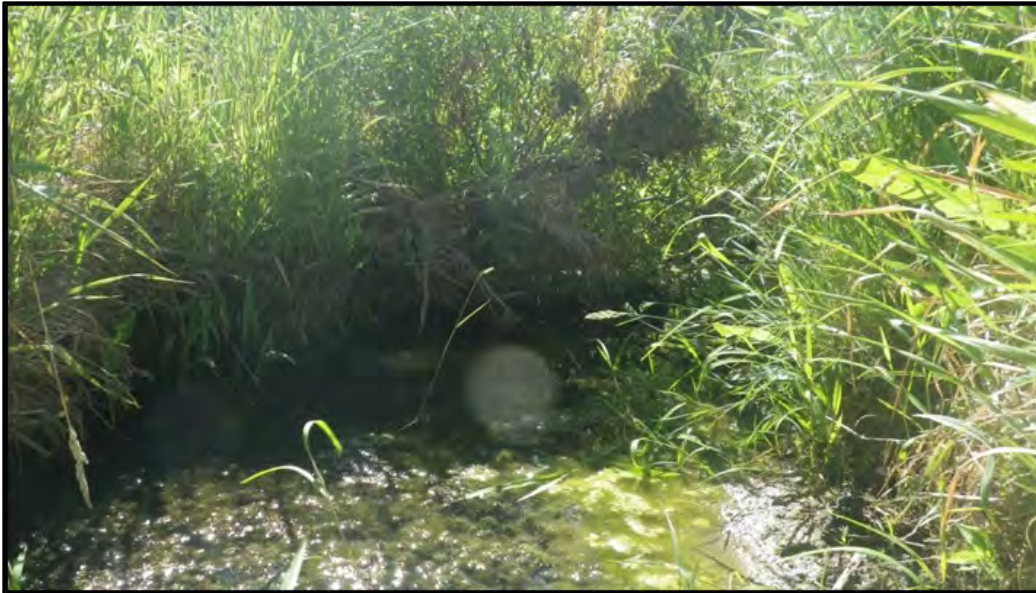
9. Reach G-3: stagnant water due to ponding upstream from Countryside Drive crossing

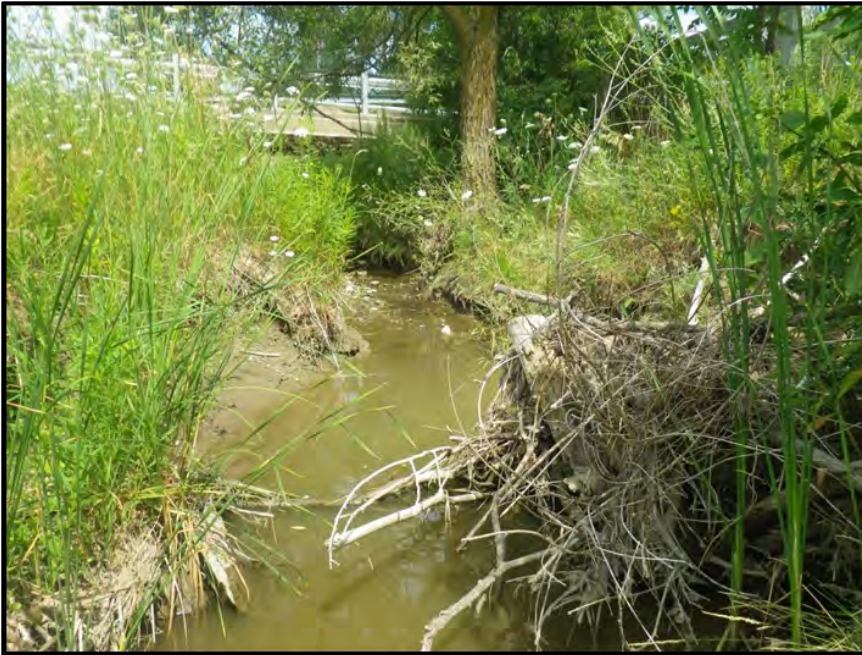
29. Reach C-7: woody debris has caused constriction of flow and local increase in erosion

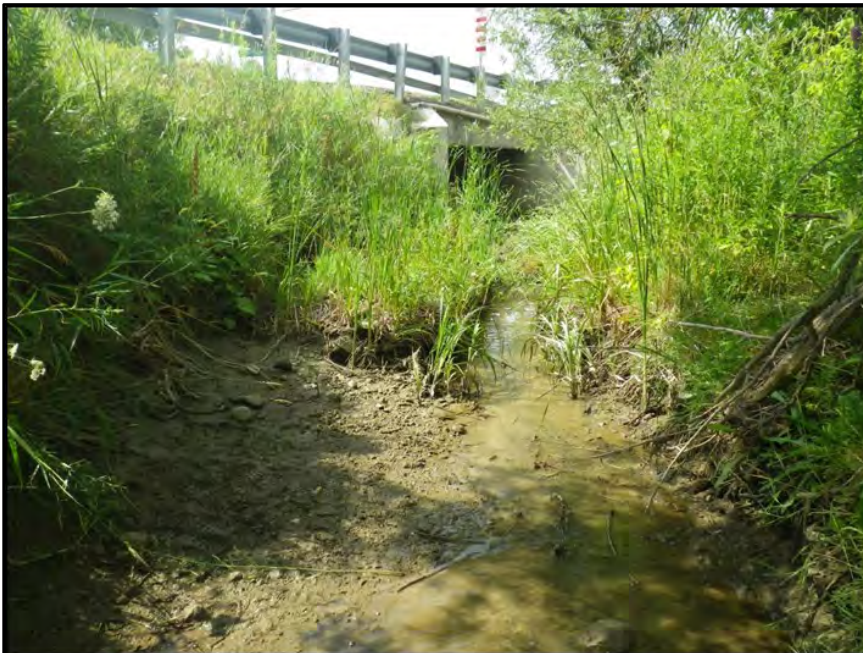
38. Reach C-8: detached bank constricts pathway approaching Countryside Drive crossing
