Key Plan
Borehole Location Plan

Client/Project: CITY OF BRAMPTON
 GEOTECHNICAL INVESTIGATION
 HEART LAKE ROAD CORRIDOR

Phase II, 2013

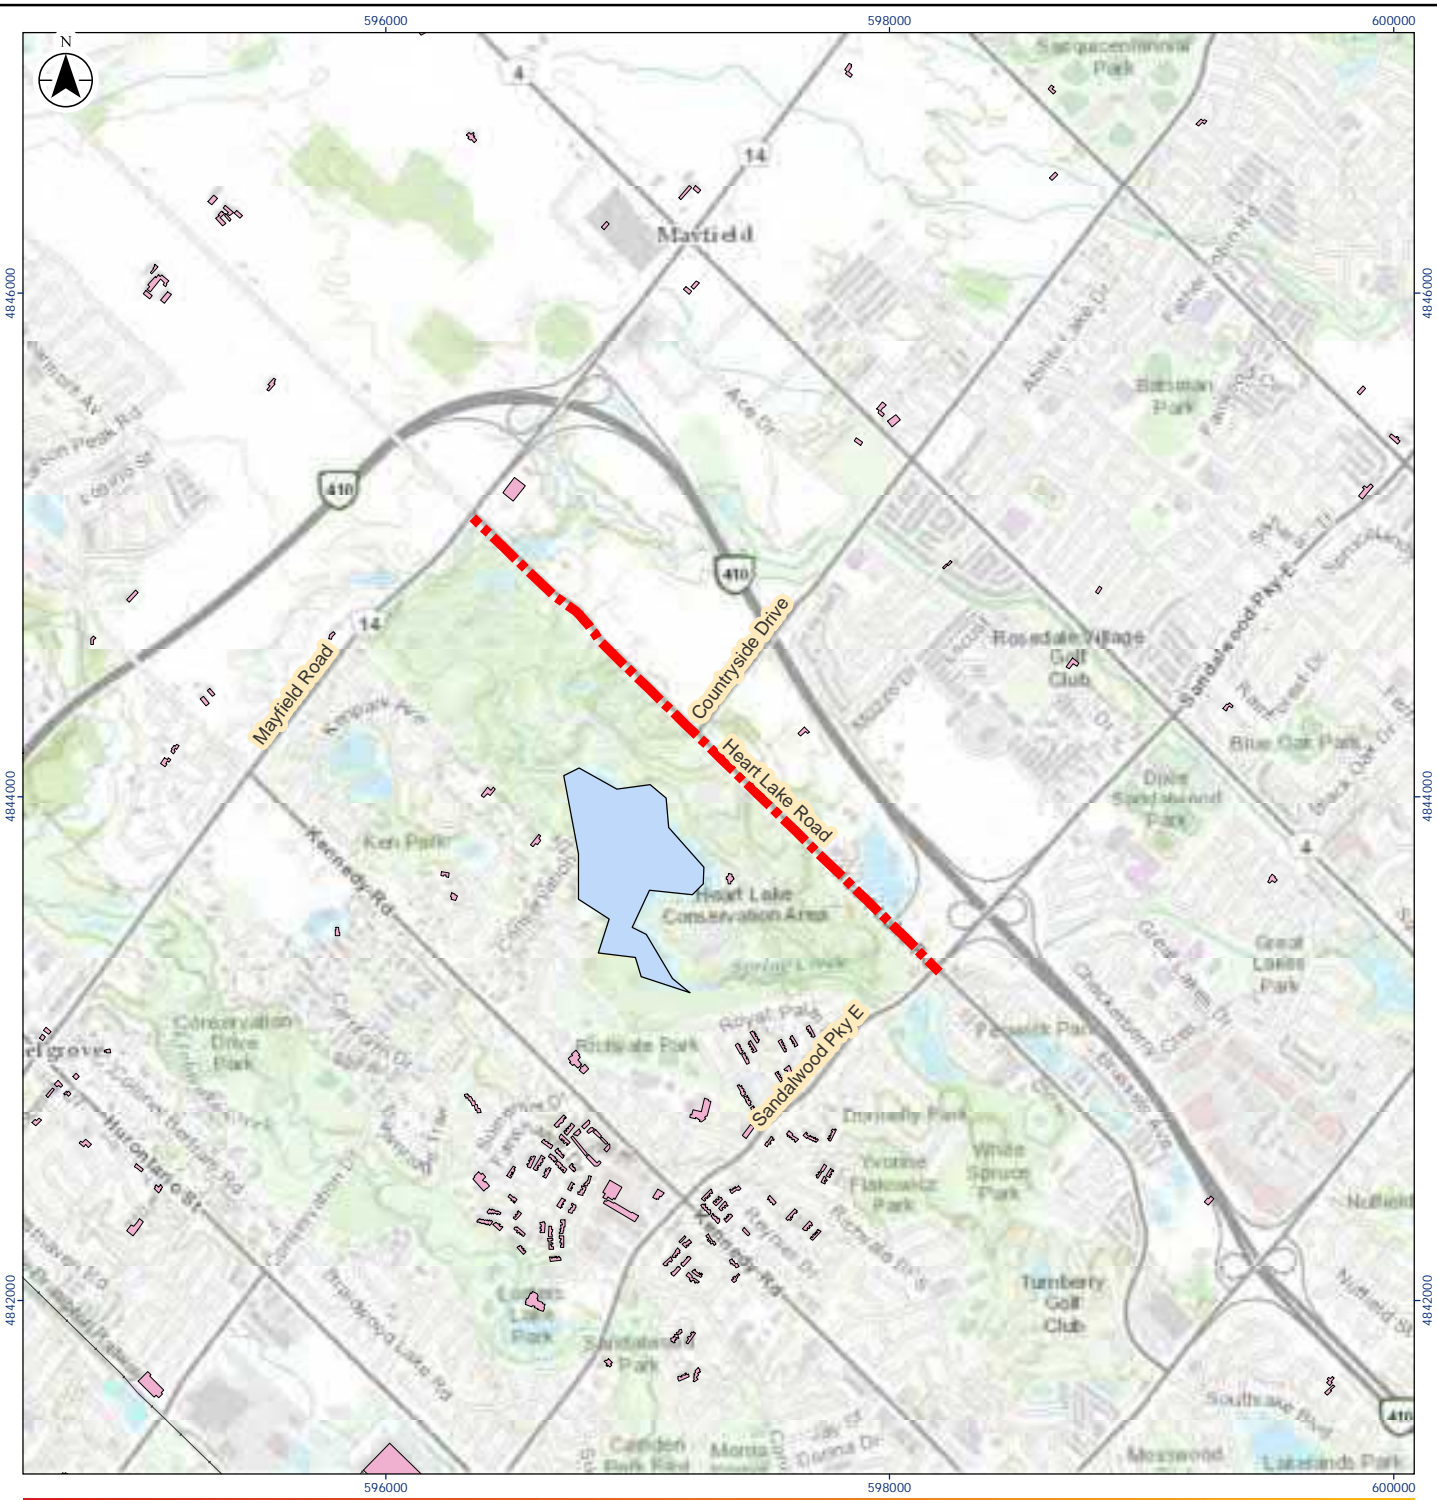
Drawing No. 1

Title: Key Plan

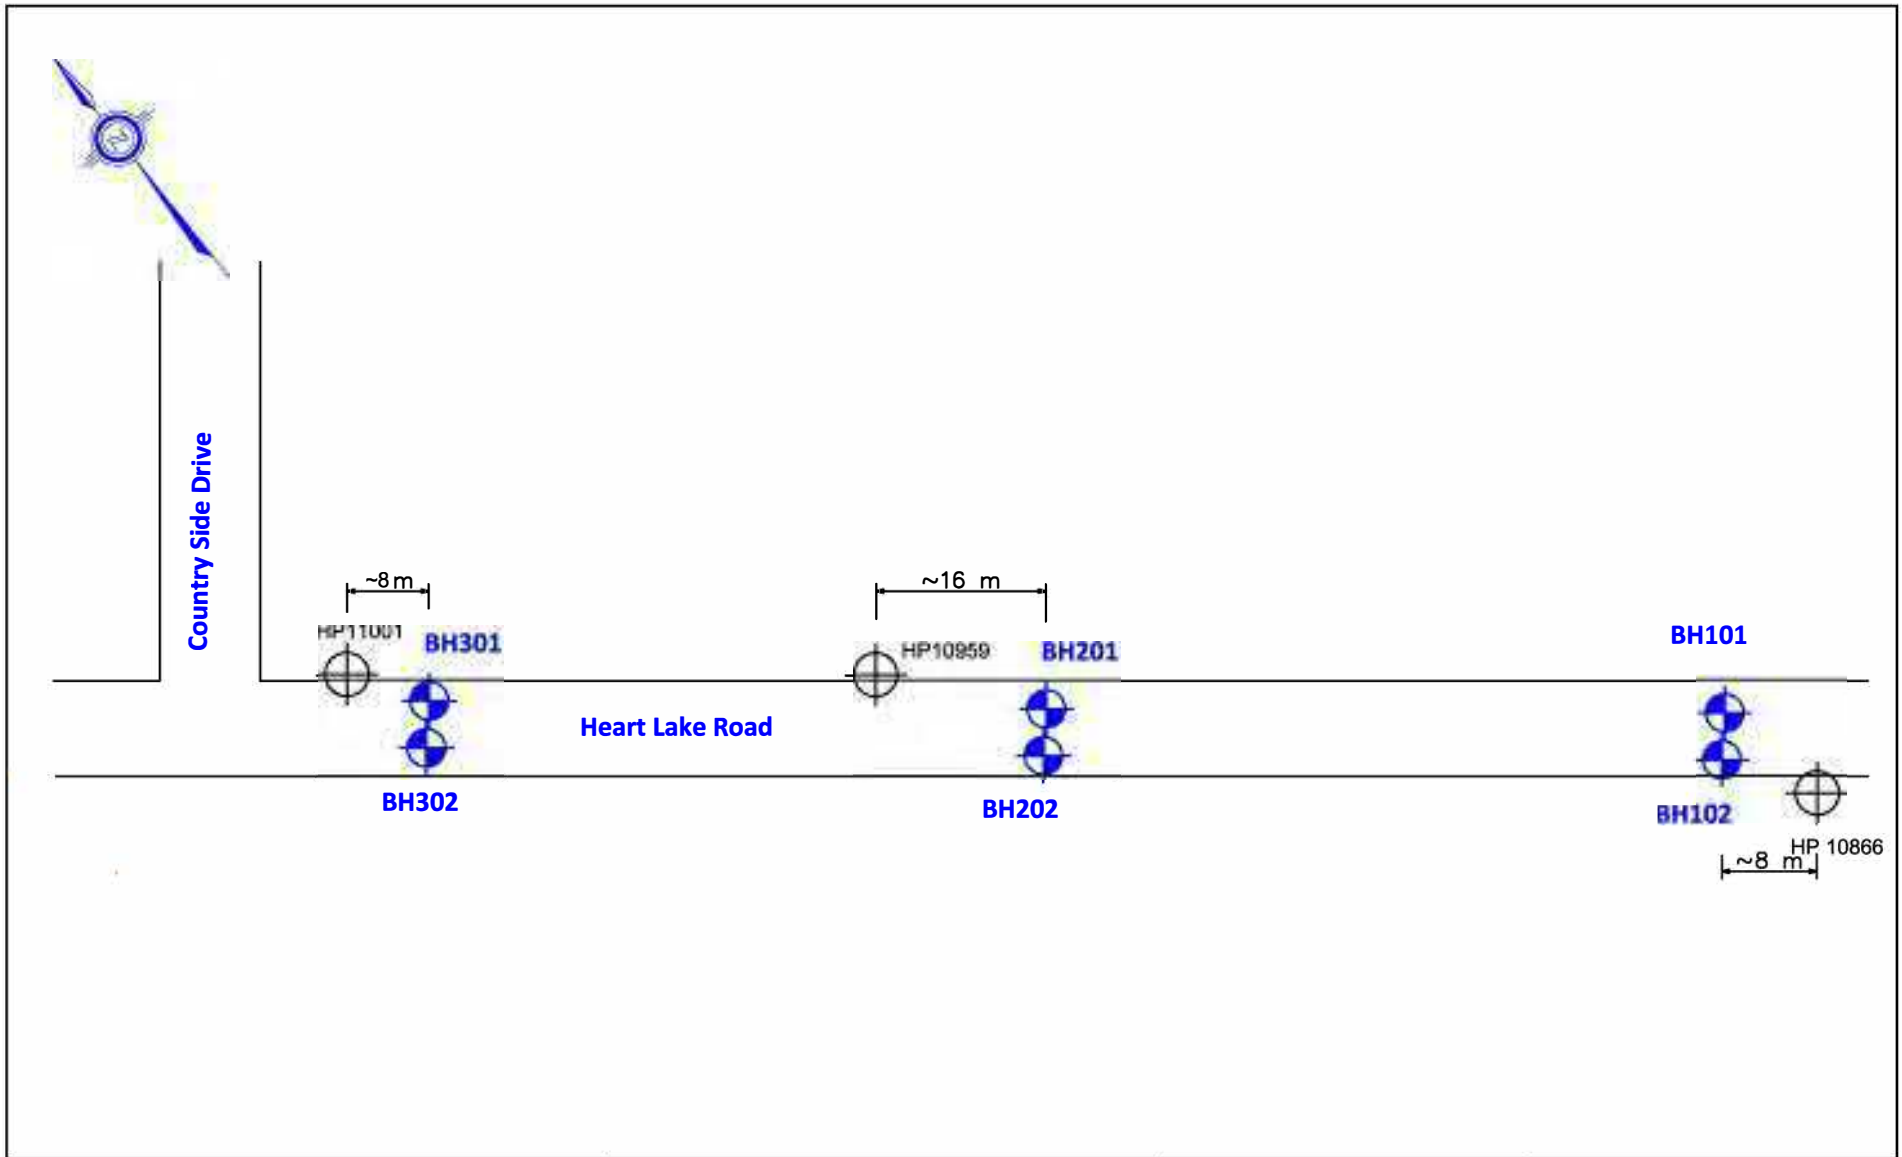
BH1 Proposed Borehole Location HP11001 Hydro Pole	Client: City of Brampton		Project No.: 15-1026B-01	Drawing No.: 1
	Drawn: GC	Approved: DL	Title: Borehole Location Plan	
	Date: October 2015	Scale: N.T.S.	Project: Geotechnical Investigation Proposed Culverts Heart Lake Road, Brampton, Ontario	
	Original Size: Letter	Rev: DL

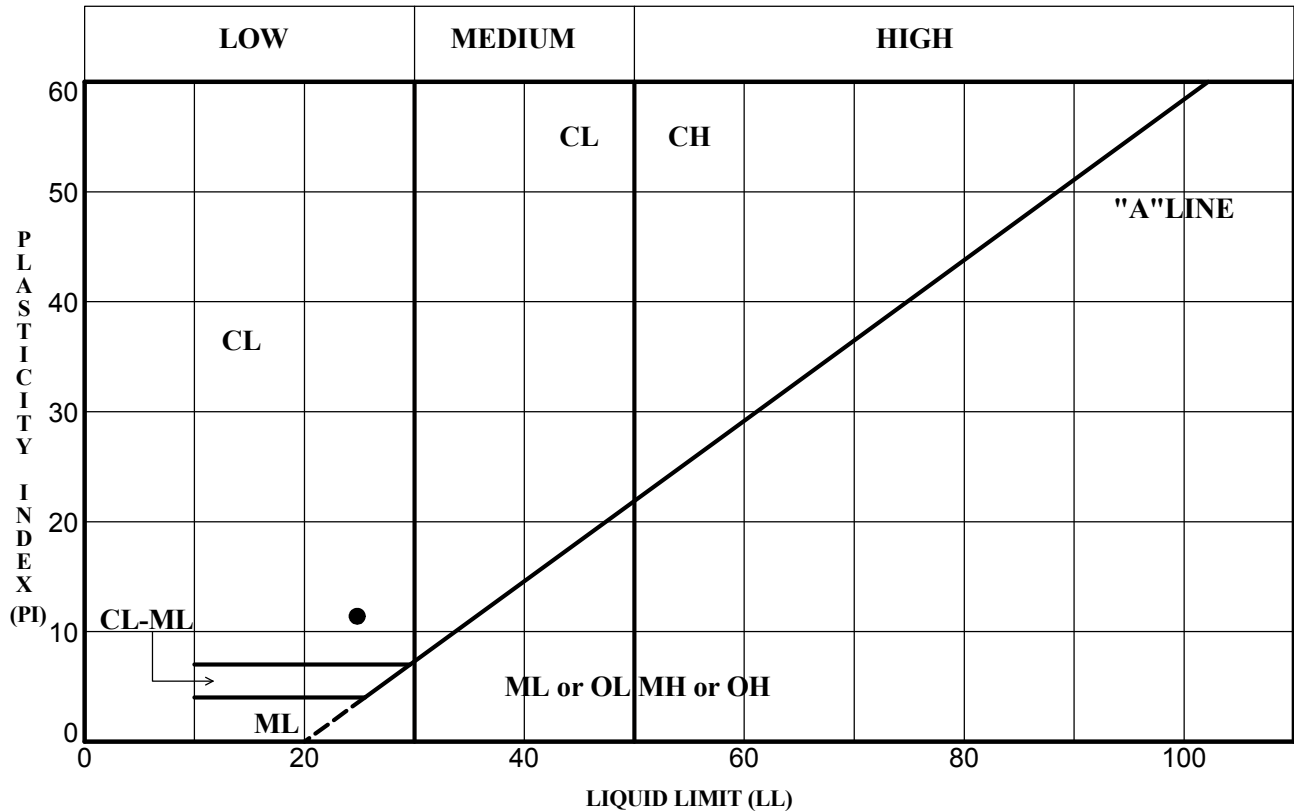
PLASTICITY CHART

Specimen	Depth (m)	LL	PL	PI	Fines	W%	Classification
● BH01-17	2.9	25	13	12	73	15	CLAY with SAND (CL) TILL

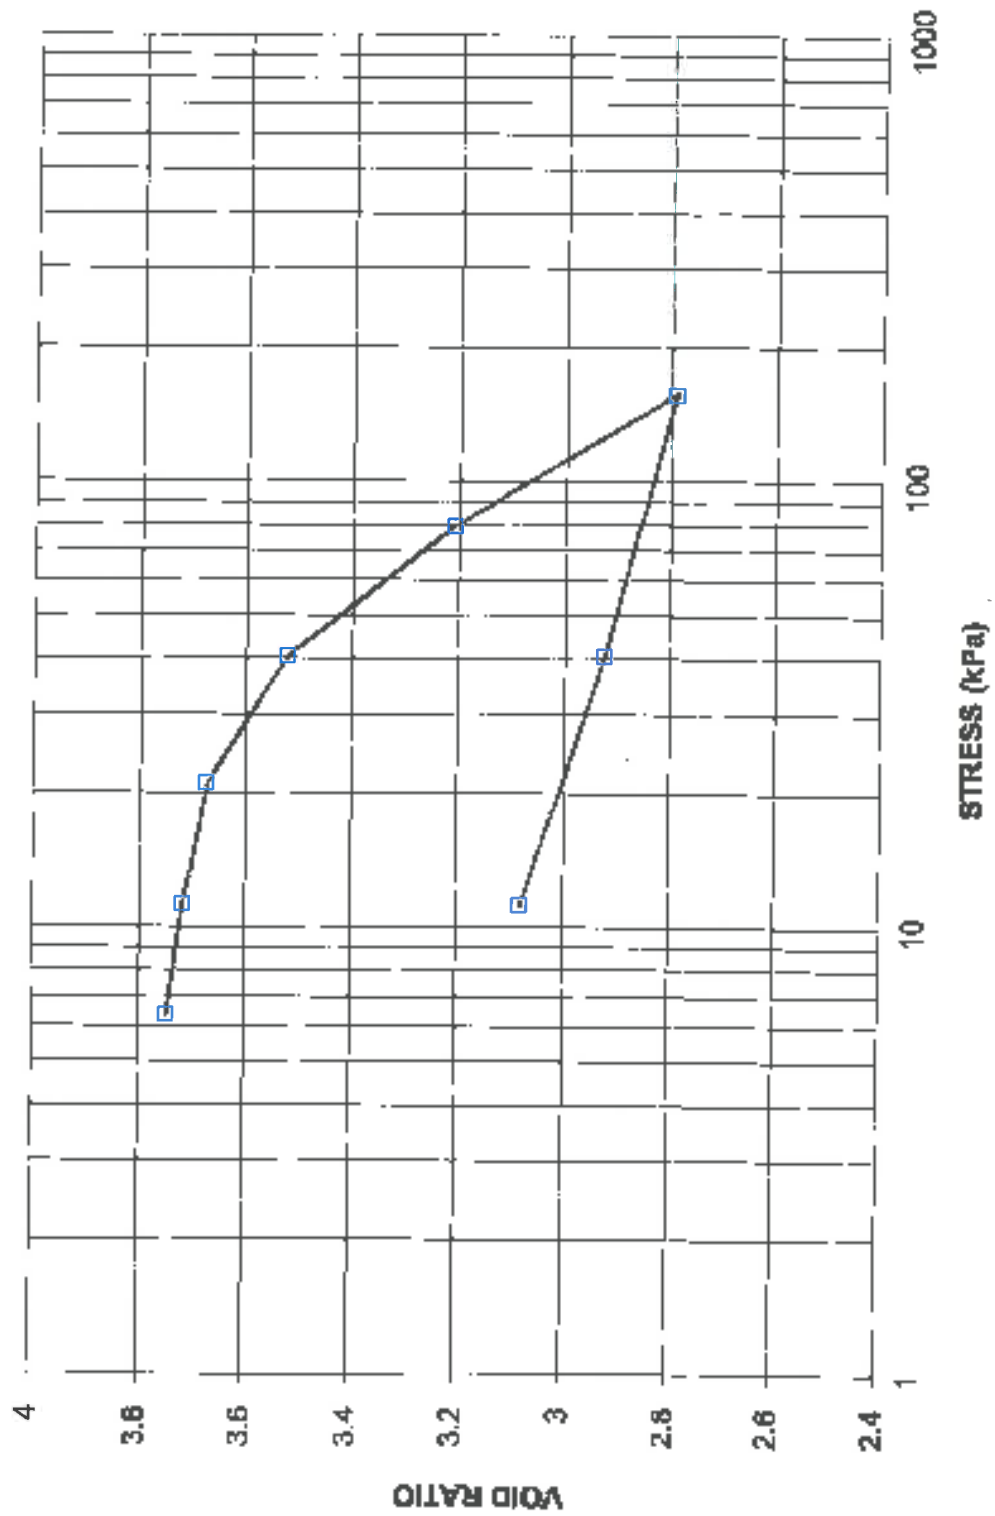
CONSOLIDATION TEST
VOID RATIO vs STRESS
BH5 ST2

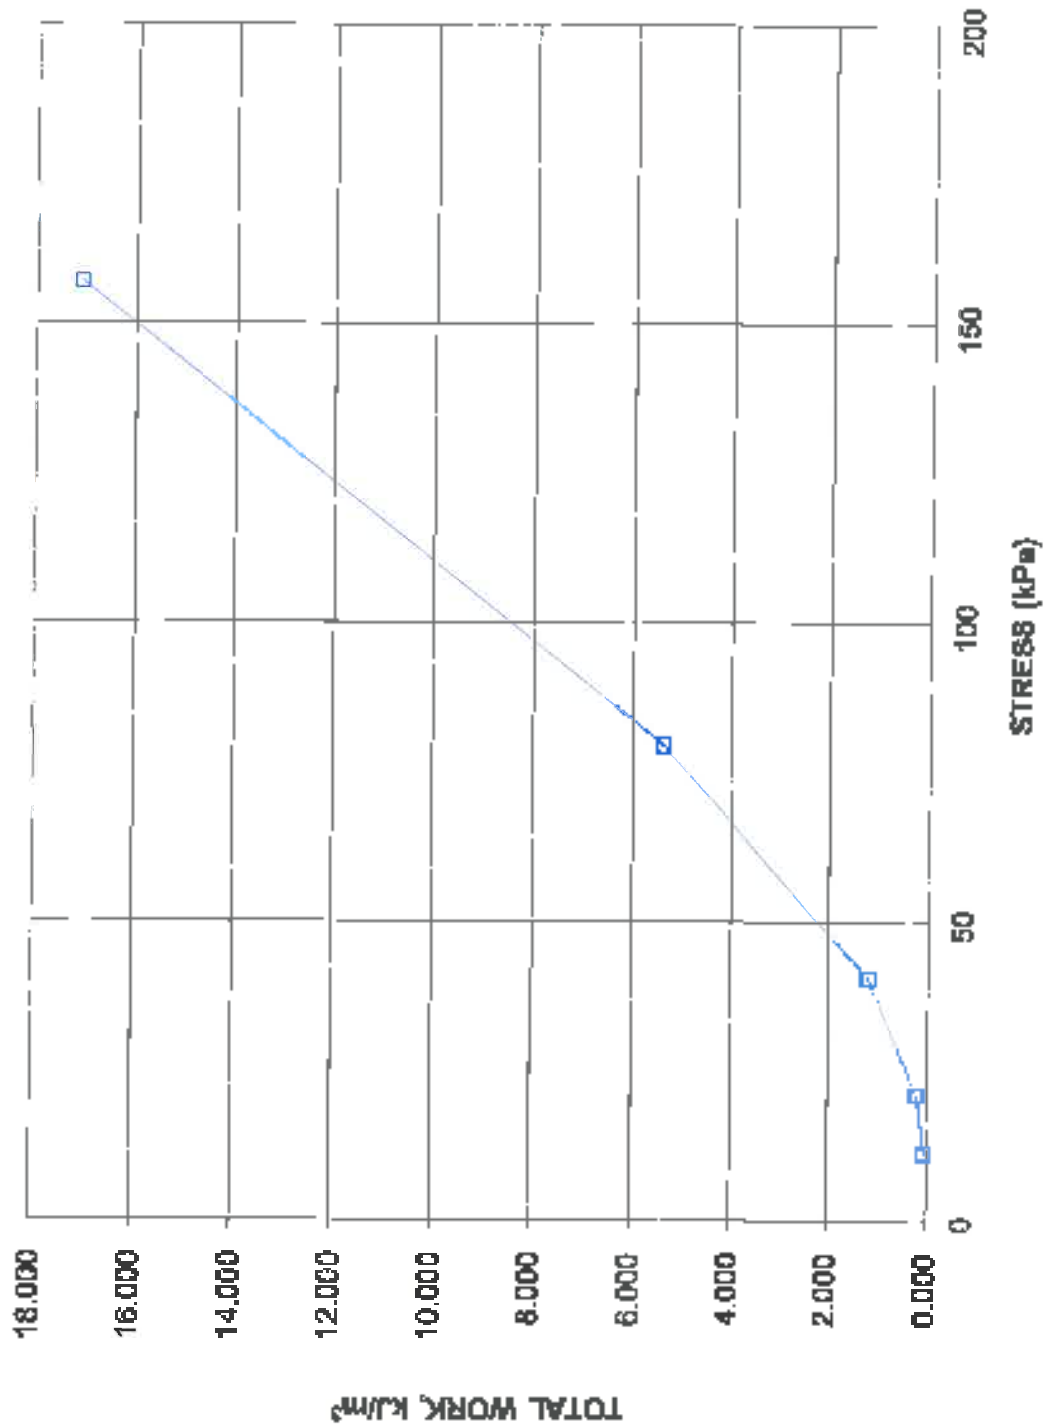
CONSOLIDATION TEST
TOTAL WORK, kJ/m³ vs STRESS
BH5 ST2

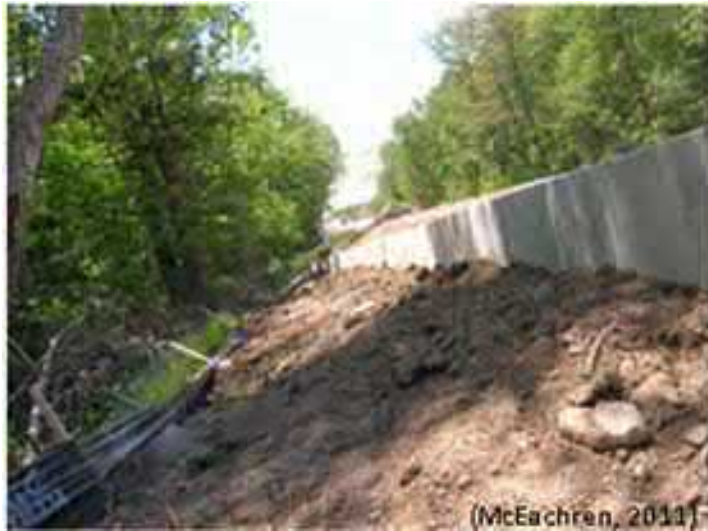
Image 6: Permanent Concrete Wall Directing Wildlife to Underpass

Tunnel and fencing systems should be strategically placed at high traffic crossing areas and guidelines of installation and maintenance should be followed. There are a small number of pre-existing culverts along Heart Lake Road which could be modified for use as wildlife pathways. When using culverts for wildlife pathways, it is essential to incorporate as much of the natural habitat as possible by placing substrate on the culvert base versus uncovered steel or concrete (Ovaska *et al.*, 2005). For the mitigation procedure to be effective it is essential that the culvert(s) be relatively close to crossing hotspots (Bissonette & Cramer, 2008). If culverts are not pre-existing at wildlife crossing hotspots, concrete box structures should be considered. The concrete box structures are larger, and with the use of overhead openings, it is brighter and therefore more inviting to reptiles, amphibians, and small mammals (McEachren, 2011). For both suggestions, fencing is essential to guiding wildlife to the crossing. Silt fencing can be used (Figure 7), however the fence must be buried a certain depth underground to prevent wildlife from crawling under. This type of barrier should be monitored and maintained on a regular basis. A more permanent solution is a concrete wall (Figure 8) that cannot be dug under, or easily destroyed (Lake Jackson Ecopassage Alliance Inc., 2011).

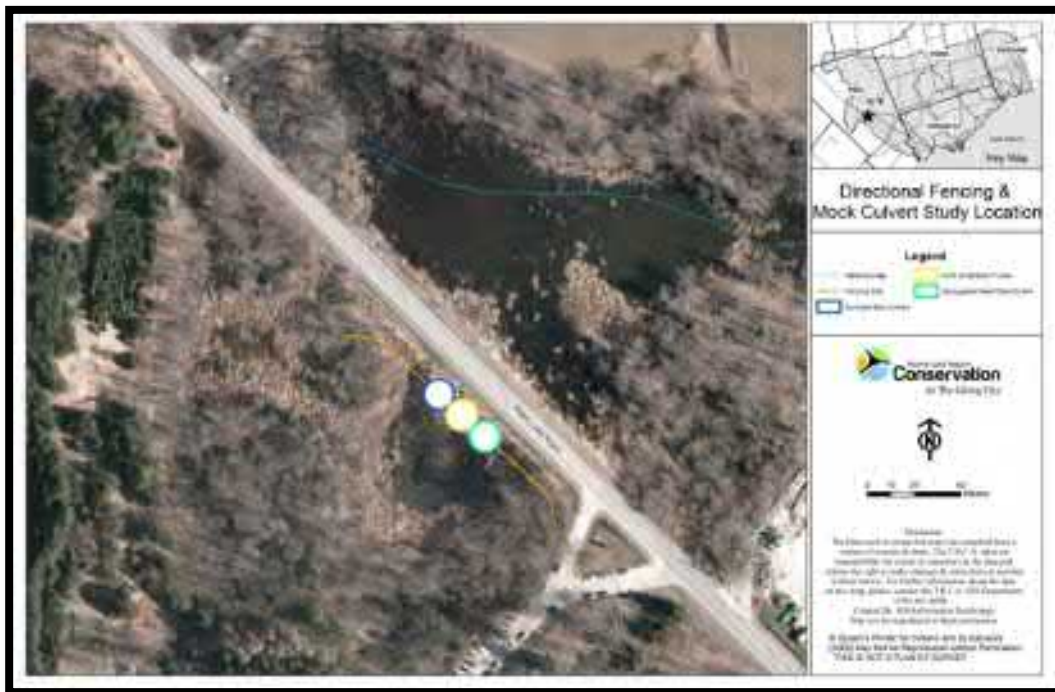
Figure 3. Directional Fencing & Culvert Study Location, west side Heart Lake Road.

In addition to the volunteer monitoring component of Phase II, a study (Appendix G) included directional fencing and three “mock culverts” being placed at the wetland on the west side of Heart Lake Road just north of HLCA entrance (Figure 3). This was undertaken in order to determine variation in efficacy in attracting and passing of three culvert types; a corrugated steel pipe (CSP), a concrete pipe and a dedicated wildlife culvert produced by ACO Systems Ltd.

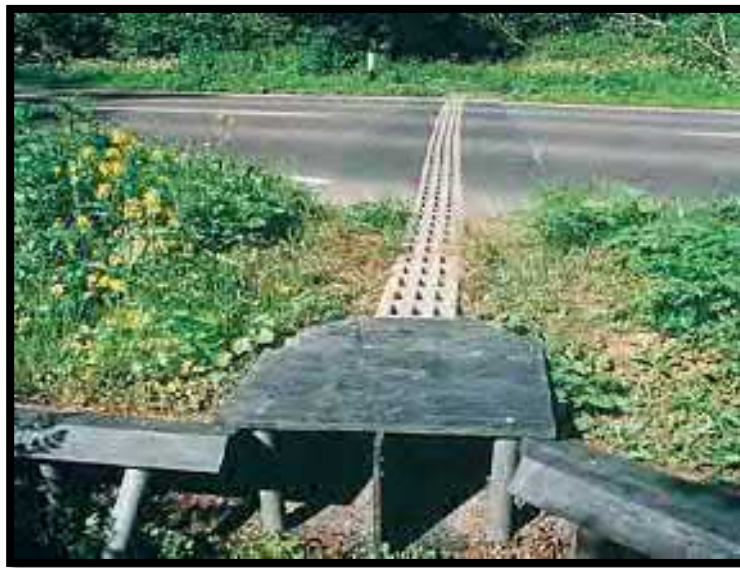
Figure 59. ACO Wildlife passage.

Depending on site conditions, perched oversized CSPs for dry passage of small wildlife can be installed or partially submerged swim-through oversized CSPs can be used for passage of aquatic small wildlife (Figure 63).

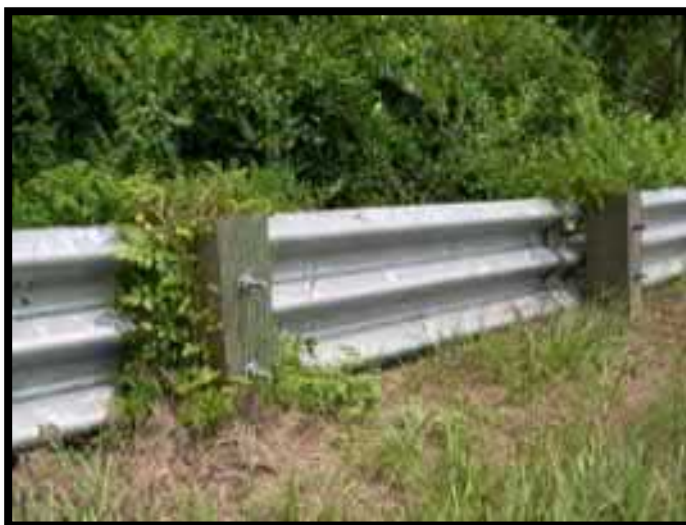
Figure 64. Directional wildlife fence, buried guardrail (Photo Credit: Aresco MJ).

having no gaps along/under fencing preventing smaller wildlife access to road, have an angled top to prevent wildlife climbing over, be of durable materials, UV resistant, able to withstand weather conditions and winter road maintenance impacts, easy to maintain and not interfere with road safety. Additionally this fencing is targeted to smaller wildlife and does not restrict movement of larger wildlife. Fencing specific for managing WVCs for larger wildlife can also be considered as part of a strategy in applicable locations (Figure 68), while still protecting smaller species.

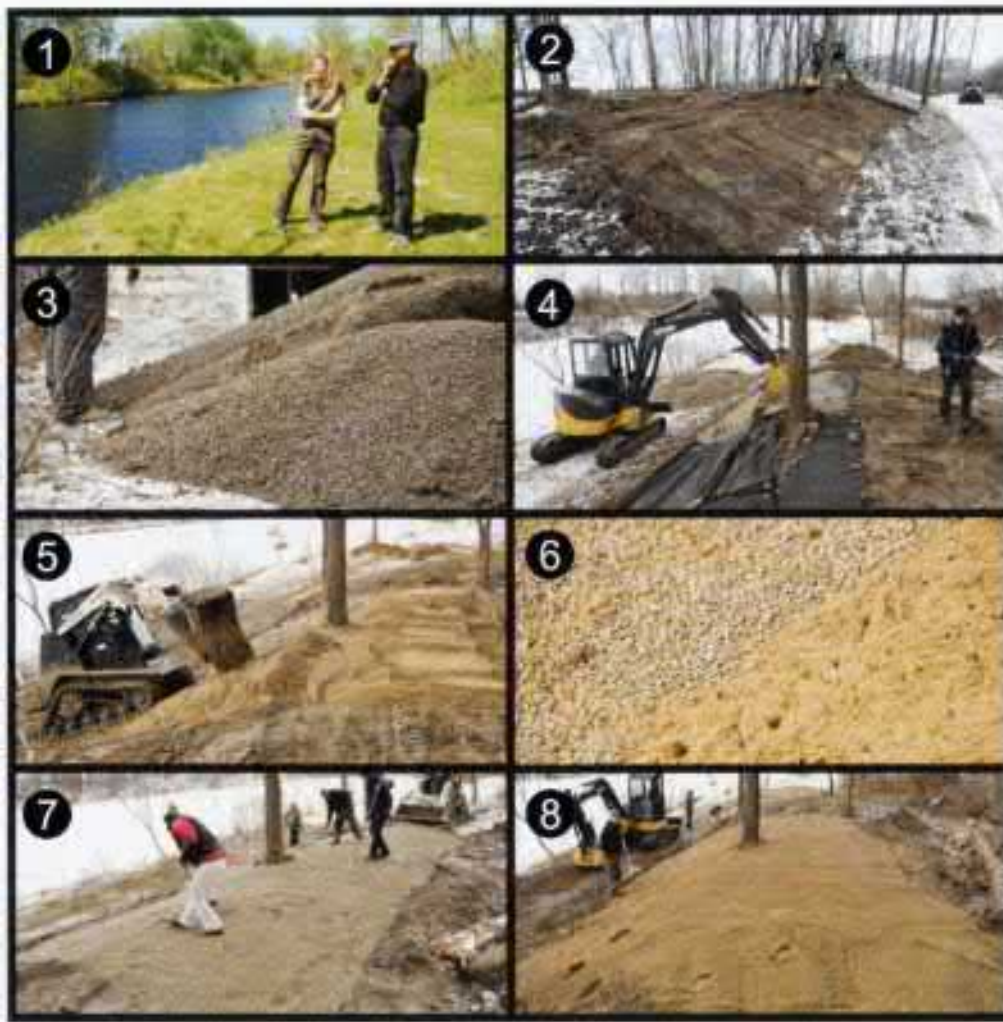
Figure 70. Steps to install turtle nesting/basking beach (Adopt-A-Pond 2012).

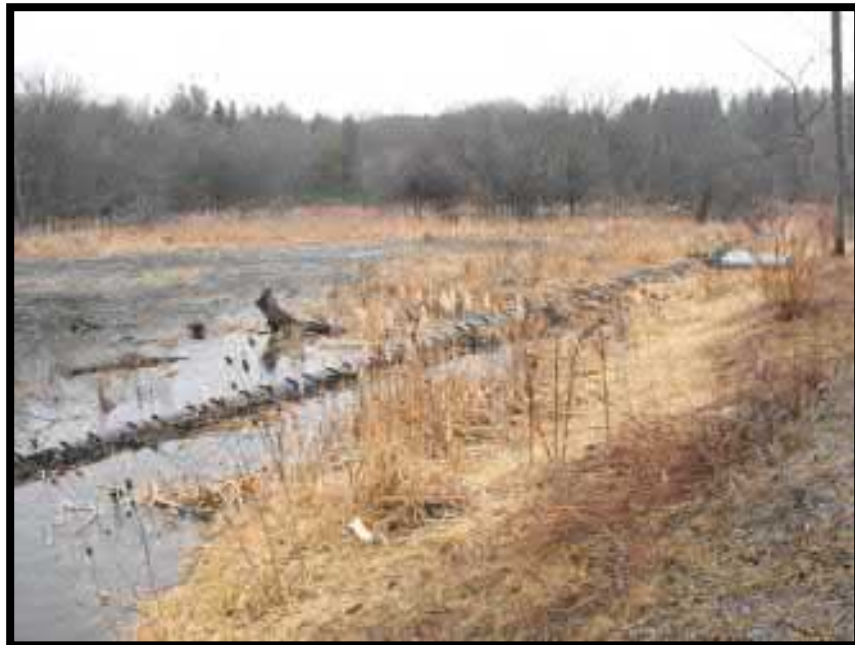
Figure 15 – Mock culverts and ACO wildlife directional fencing in place

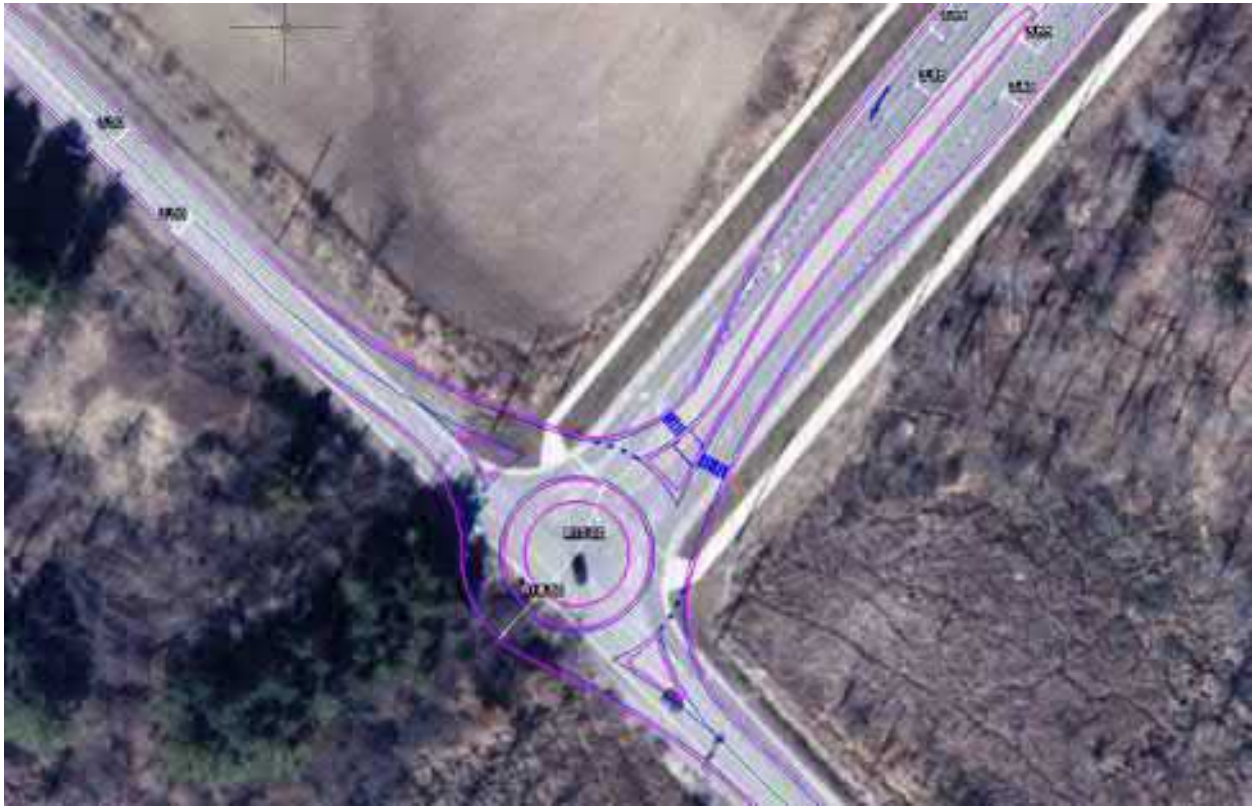
Figure 49: Roundabout at Countryside Option 1 (with encroachment on TRCA lands)

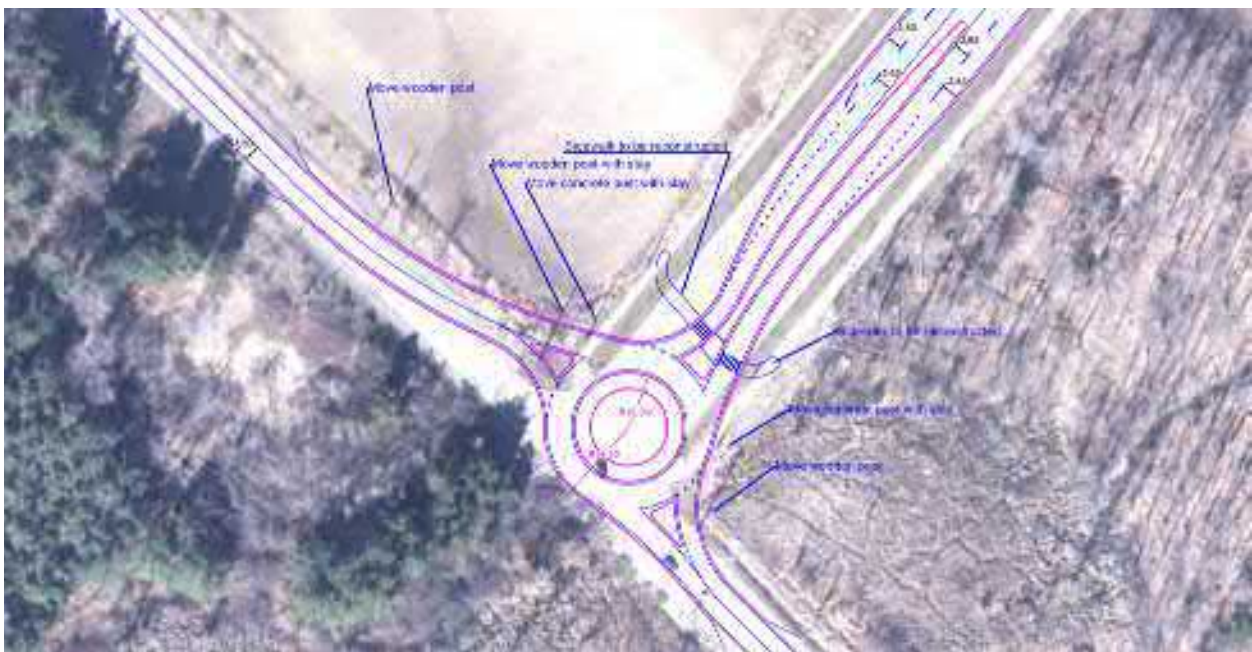
Figure 50: Roundabout at Countryside Option 2 (without encroachment on TRCA lands)
