Presentation for Various Project Meetings

Heart Lake Rd. & Countryside Dr. Class EA

Technical Advisory Committee (TAC) Meeting November 21, 2021

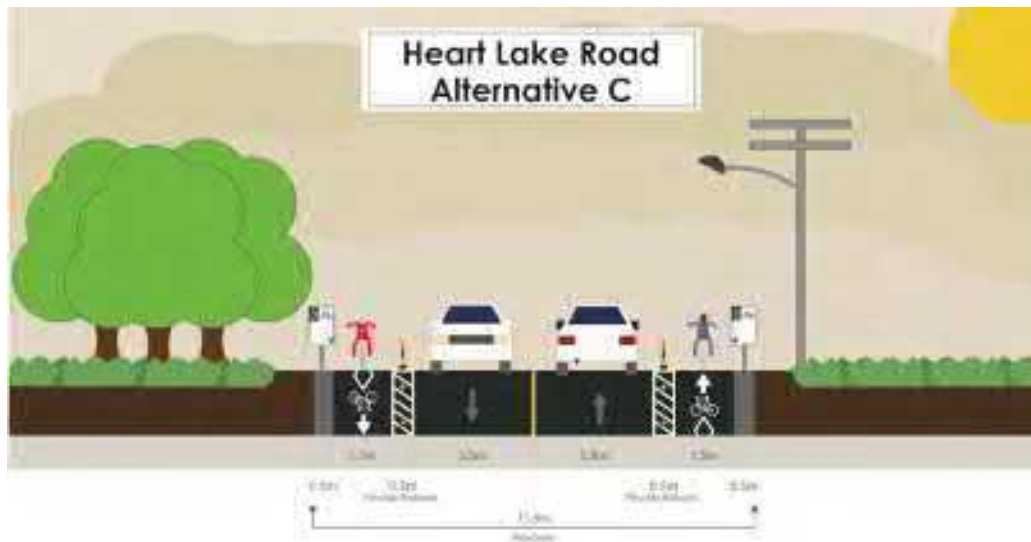
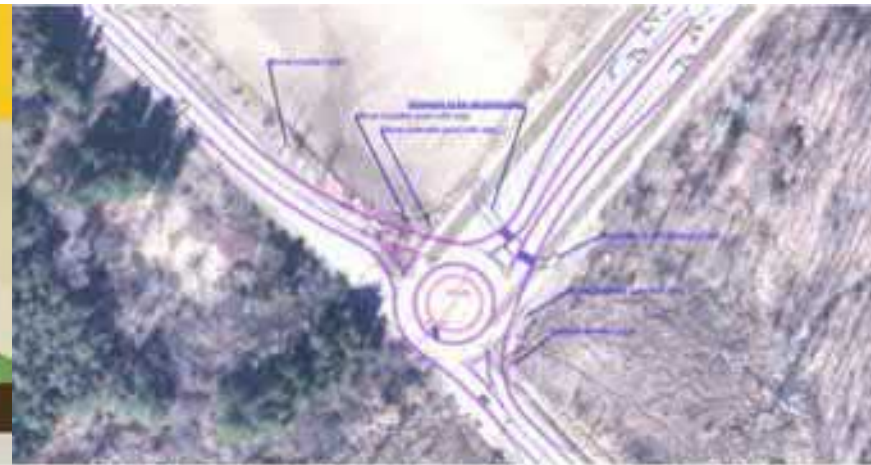
Figure 50: Roundabout at Countryside Option 2 (without encroachment on TRCA lands)

Separated bike lanes on Heart Lake Rd. & Roundabout at Countryside

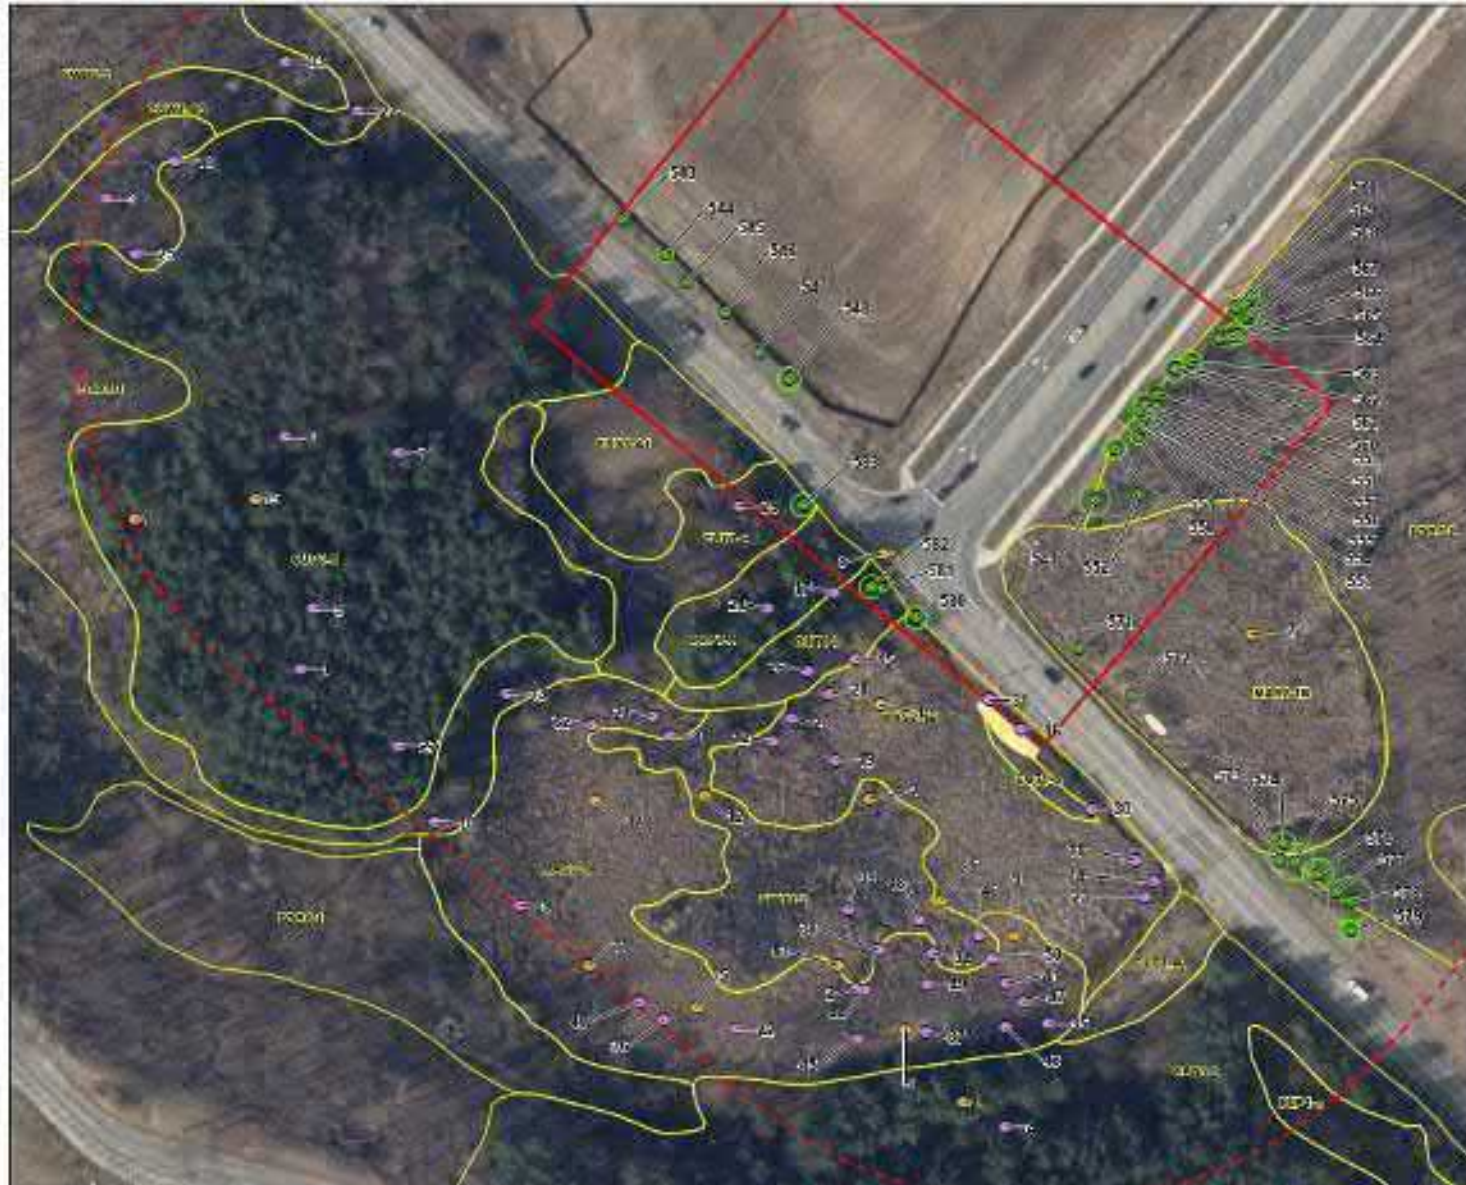
- ✓ Natural Environment Study (Beacon)
- ✓ Drainage Study (MTE)
- ✓ Phase I ESA (MTE)
- ✓ Stage 1 Archaeological Investigation (ARA)
- ✓ Cultural/Built Heritage Study (ARA)
- ✓ Geotechnical Investigation (MTE)

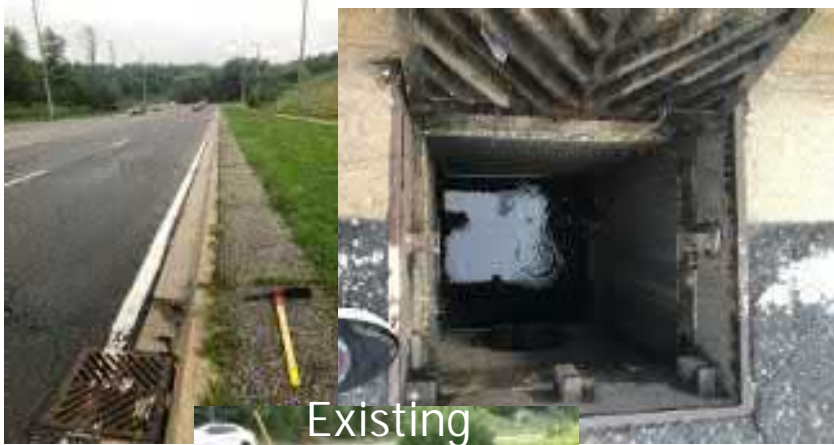
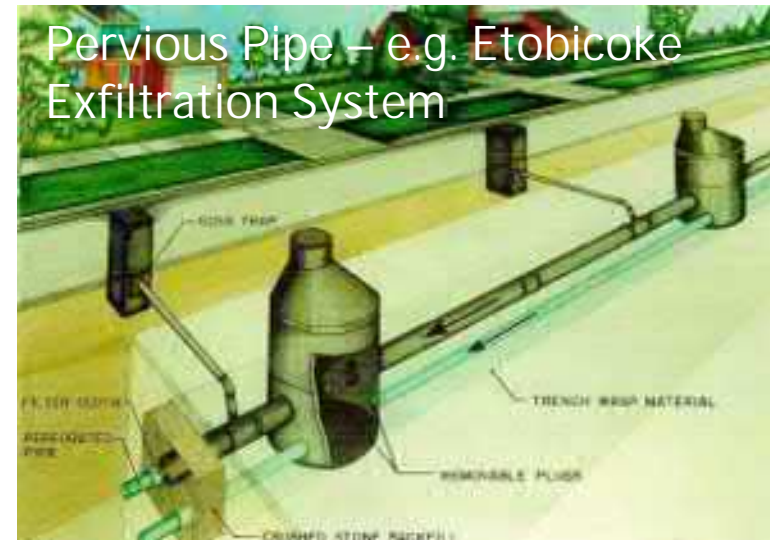
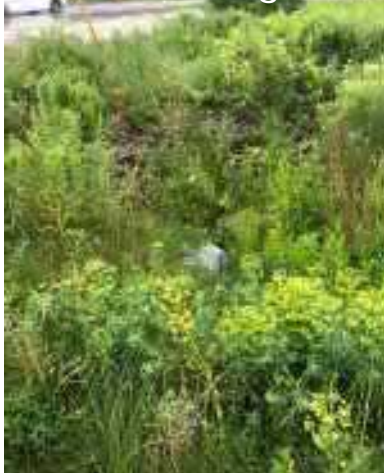
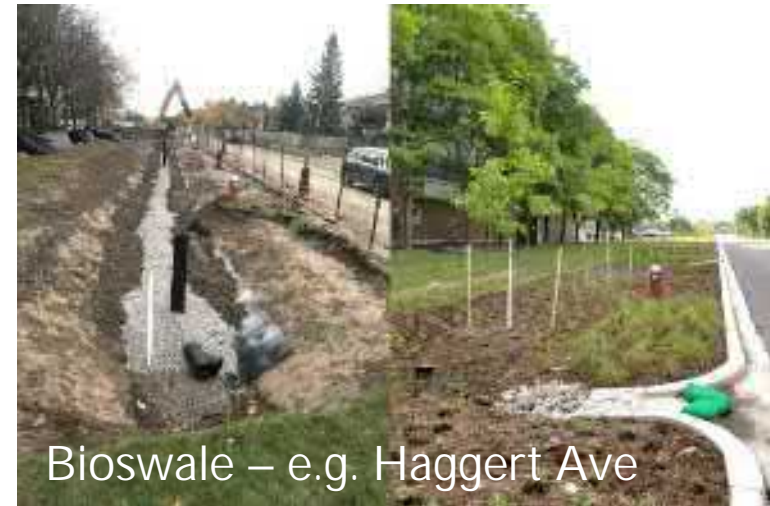
- ✓ Draft study has been submitted to TRCA for review;
- ✓ Drainage basically the same as existing for signalized intersection;
- ✓ Roundabout results in an extra 14 l/s during 100 year storm compared to signalized intersection
- ✓ LID's recommended for quantity/quality control;
- ✓ Development drainage details to west (south side) on Countryside Drive to be included prior to construction IF their flows reach the Countryside Dr. road allowance.

Existing	Proposed
<ul style="list-style-type: none">• 300 mm storm sewer with sub drains	<ul style="list-style-type: none">• Replace existing and enhance with LID to promote infiltration
<ul style="list-style-type: none">• Ditch drainage with culvert crossing Countryside Drive	<ul style="list-style-type: none">• Re-grade / enhance ditches and replace / relocate culvert
<ul style="list-style-type: none">• Overland flow draining to ditch / wetlands (generally uncontrolled drainage)	<ul style="list-style-type: none">• Flows contained and conveyed into ditches or infiltrated within project limits

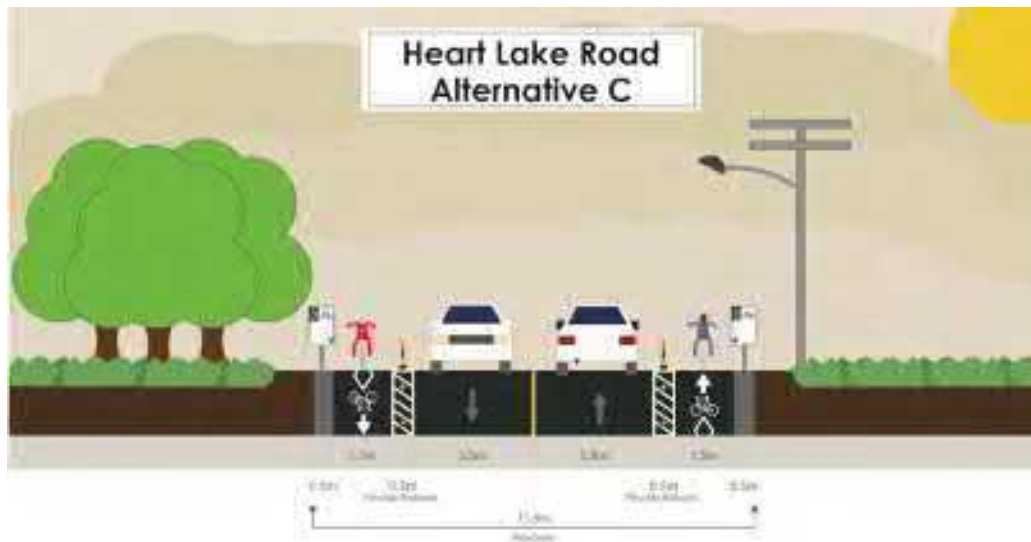
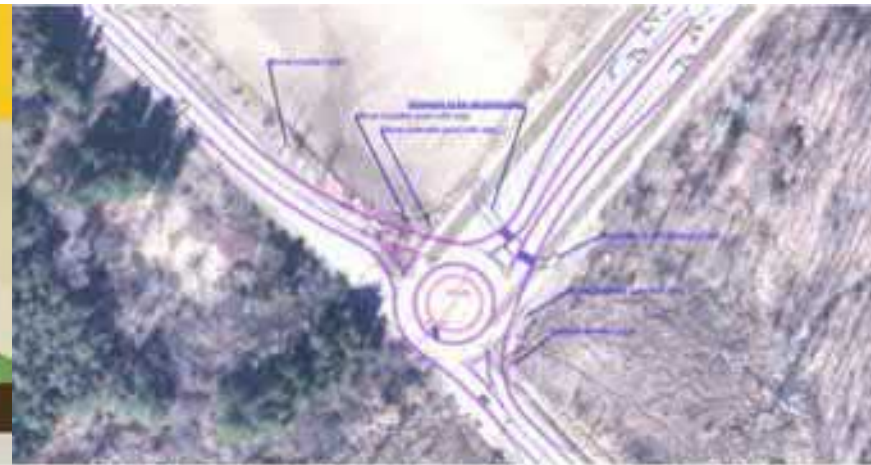
Figure 50: Roundabout at Countryside Option 2 (without encroachment on TRCA lands)

Separated bike lanes on Heart Lake Rd. & Roundabout at Countryside

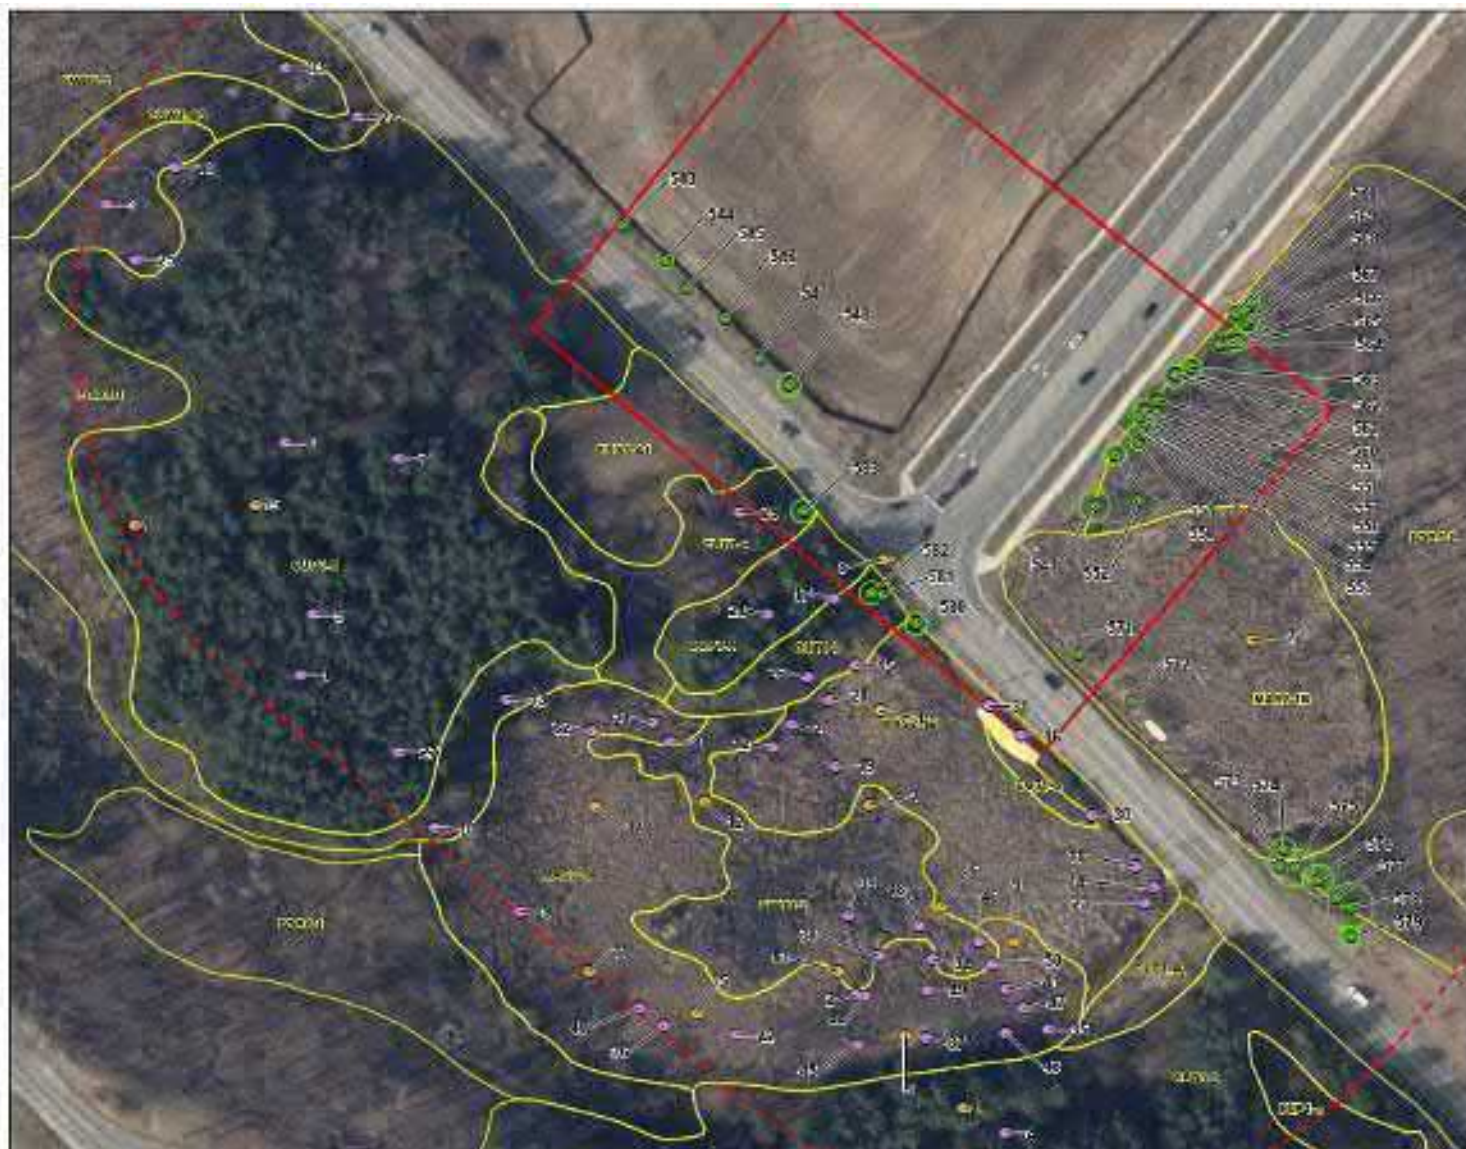
Existing Conditions		Figure 2
Heart Lake Road and Countryside Drive Environmental Assessment, City of Brampton		
Legend		
	Subject Property	
	Study Area (120 m)	
	Turtle Nesting Berms	
	Vegetation Communities	
	Surveyed Tree Crown Radius	
	Surveyed Trees	
	Fauna (TRCA)	
	Flora (TRCA)

Code	Vegetation Community
CUF1-C	Lowest Deciduous Plantation
CUF4-B	White Pine Coniferous Hardwood
CUF3-F	Mixed Conifer Coniferous Plantation
COB1-A1	Native Deciduous Successional Woodland
COF1-B	Nonnative Deciduous Thicket
COF1-C	Native Deciduous Thicket
COF1-A3	Native Deciduous Successional Woodland
FGD1-2	Dry - Fresh Sugar Maple - Birch Deciduous Forest
FGD1-1	Fresh Moist Sugar Maple - Ash Deciduous Forest
FGD1-3	Fresh Moist Poplar Deciduous Forest
WMA1-04	Narrow-leaved Cattail Mineral Shallow Marsh
WACT-1A	Broad-leaved Cattail Organic Shallow Marsh
WDR1-1	Savanna Maple Organic Deciduous Swale
WDR1-2	White Organic Hardwood Swale

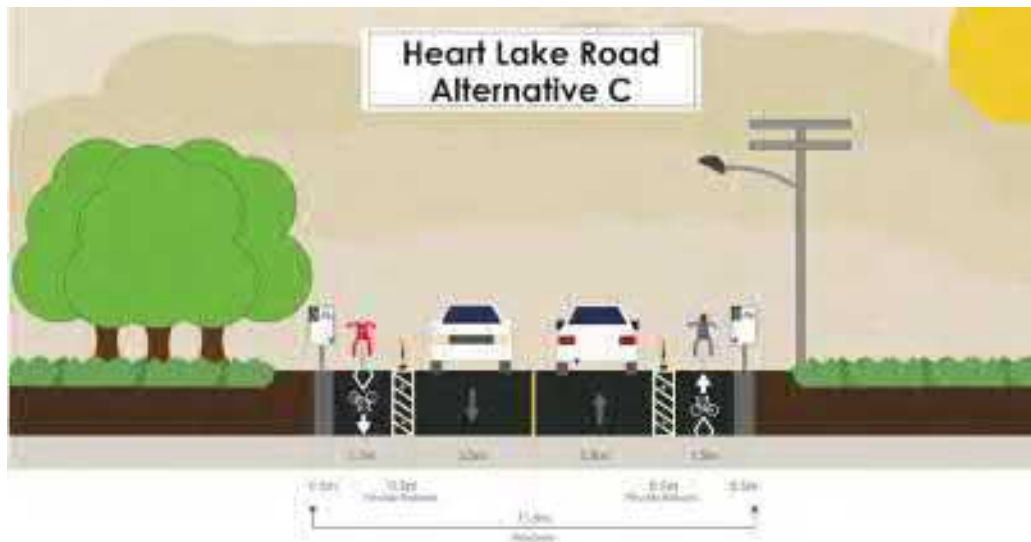
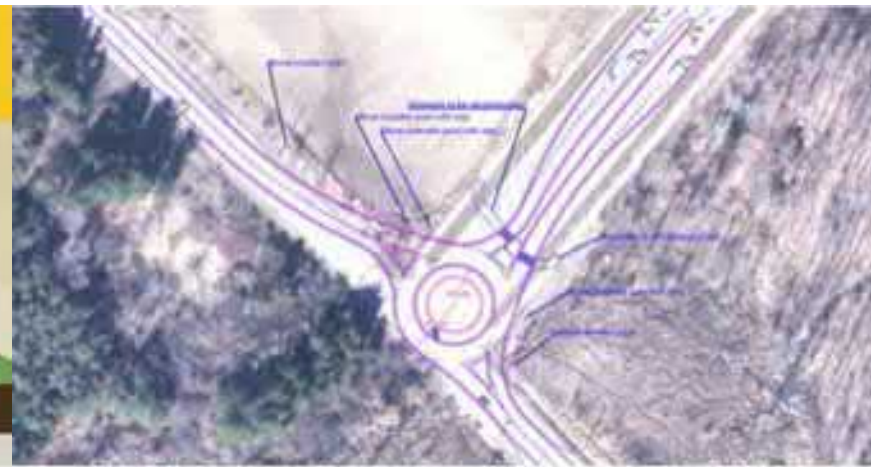
Figure 50: Roundabout at Countryside Option 2 (without encroachment on TRCA lands)

Separated bike lanes on Heart Lake Rd. & Roundabout at Countryside

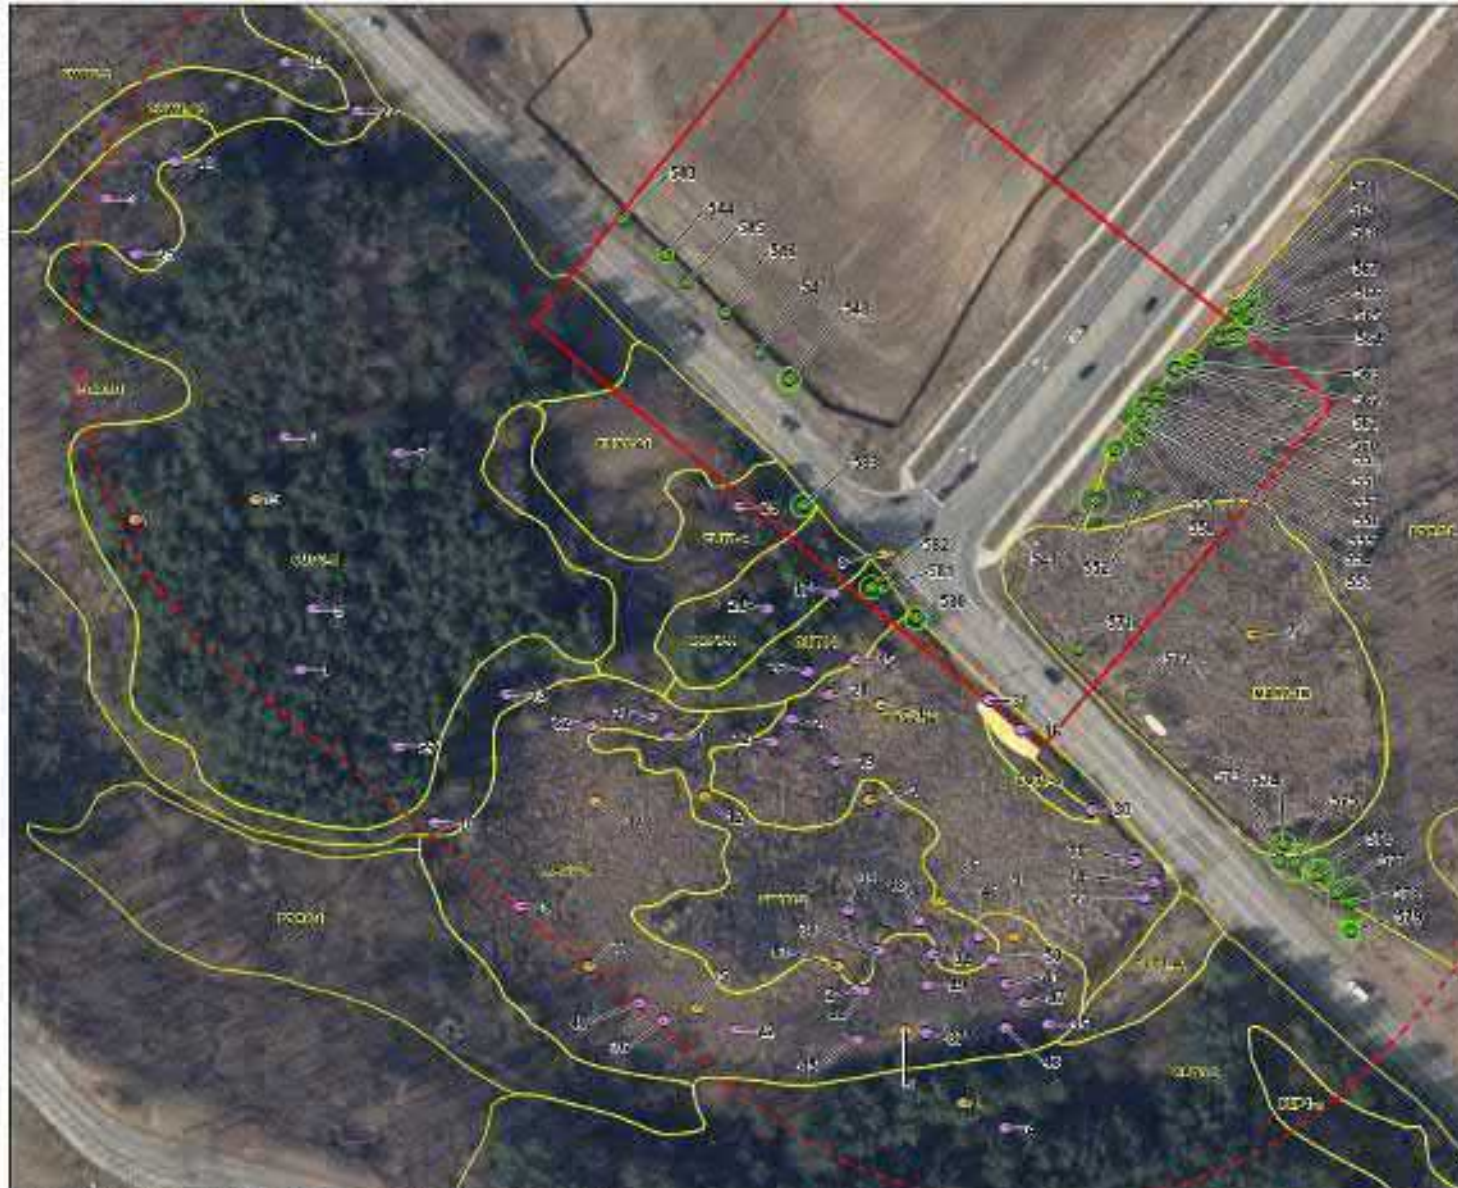
- ✓ Natural Environment Study (Beacon)
- ✓ Drainage Study (MTE)
- ✓ Phase I ESA (MTE)
- ✓ Stage 1 Archaeological Investigation (ARA)
- ✓ Cultural/Built Heritage Study (ARA)
- ✓ Geotechnical Investigation (MTE)

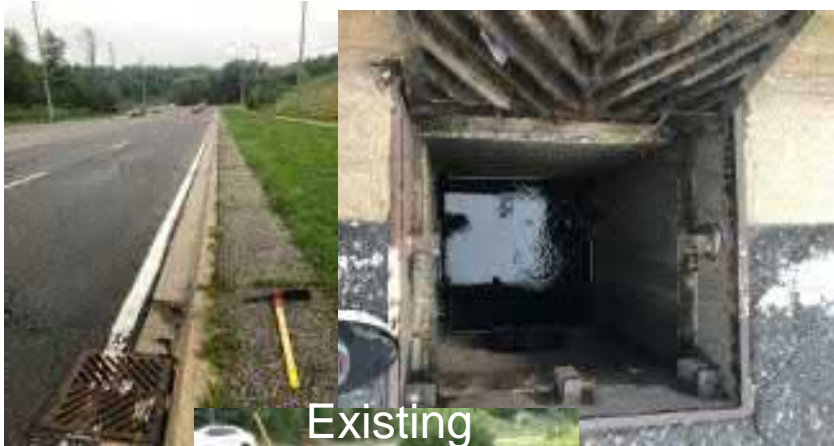
- ✓ Revised Draft study has been submitted to TRCA;
- ✓ Drainage basically the same as existing for signalized intersection;
- ✓ Roundabout results in an extra 14 l/s during 100 year storm compared to signalized intersection
- ✓ LID's recommended for quantity/quality control;
- ✓ Development drainage details to east (south side) on Countryside Drive to be included prior to construction **IF** their flows reach the Countryside Dr. road allowance.

Existing	Proposed
<ul style="list-style-type: none">• 300 mm storm sewer with sub drains	<ul style="list-style-type: none">• Replace existing and enhance with LID to promote infiltration
<ul style="list-style-type: none">• Ditch drainage with culvert crossing Countryside Drive	<ul style="list-style-type: none">• Re-grade / enhance ditches and replace / relocate culvert
<ul style="list-style-type: none">• Overland flow draining to ditch / wetlands (generally uncontrolled drainage)	<ul style="list-style-type: none">• Flows contained and conveyed into ditches or infiltrated within project limits

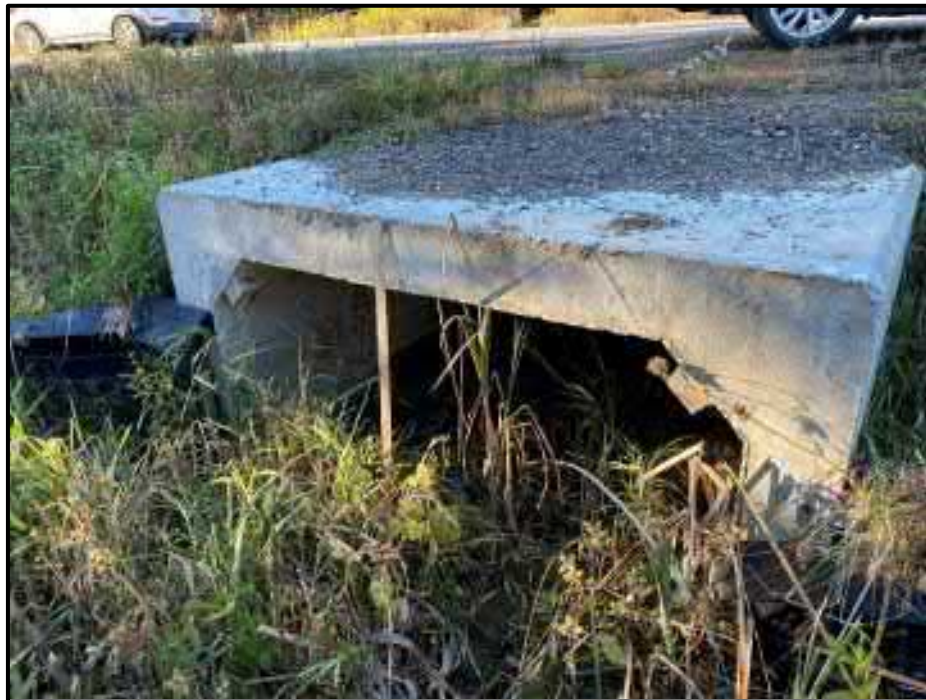
Photograph 2. Wildlife Culvert with Fencing in Foreground, and Heart Lake Road in Background (October 8, 2020)

Additionally, the TRCA has been studying road mortality on Heart Lake Road south of Countryside Drive and have found that turtle mortalities are very high for the section of Heart Lake Road east of Countryside Drive. In response to that, a wildlife crossing structure (open-bottom box culvert) and directional wildlife fencing have been installed, as shown in **Photograph 2** below. In addition to this, as illustrated on **Figure 2**, two turtle nesting berms exist on either side of Heart Lake Road south of Countryside Drive have also been installed.

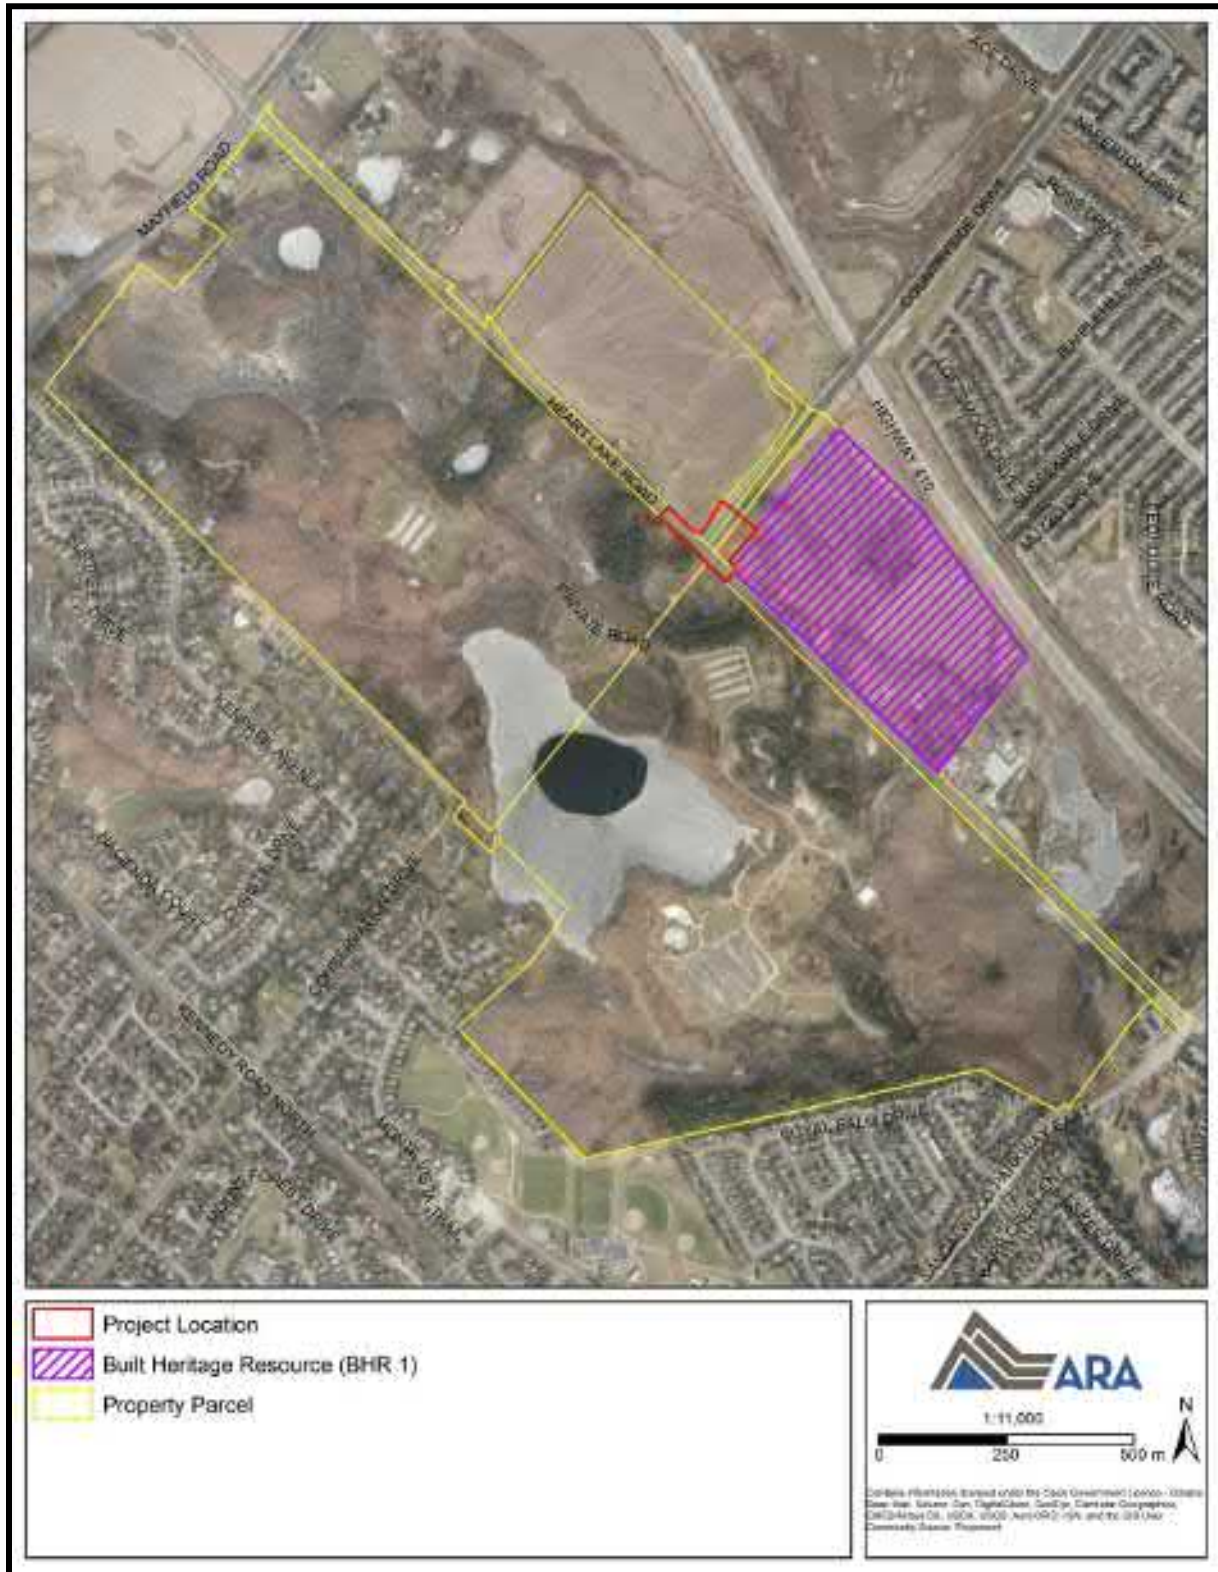
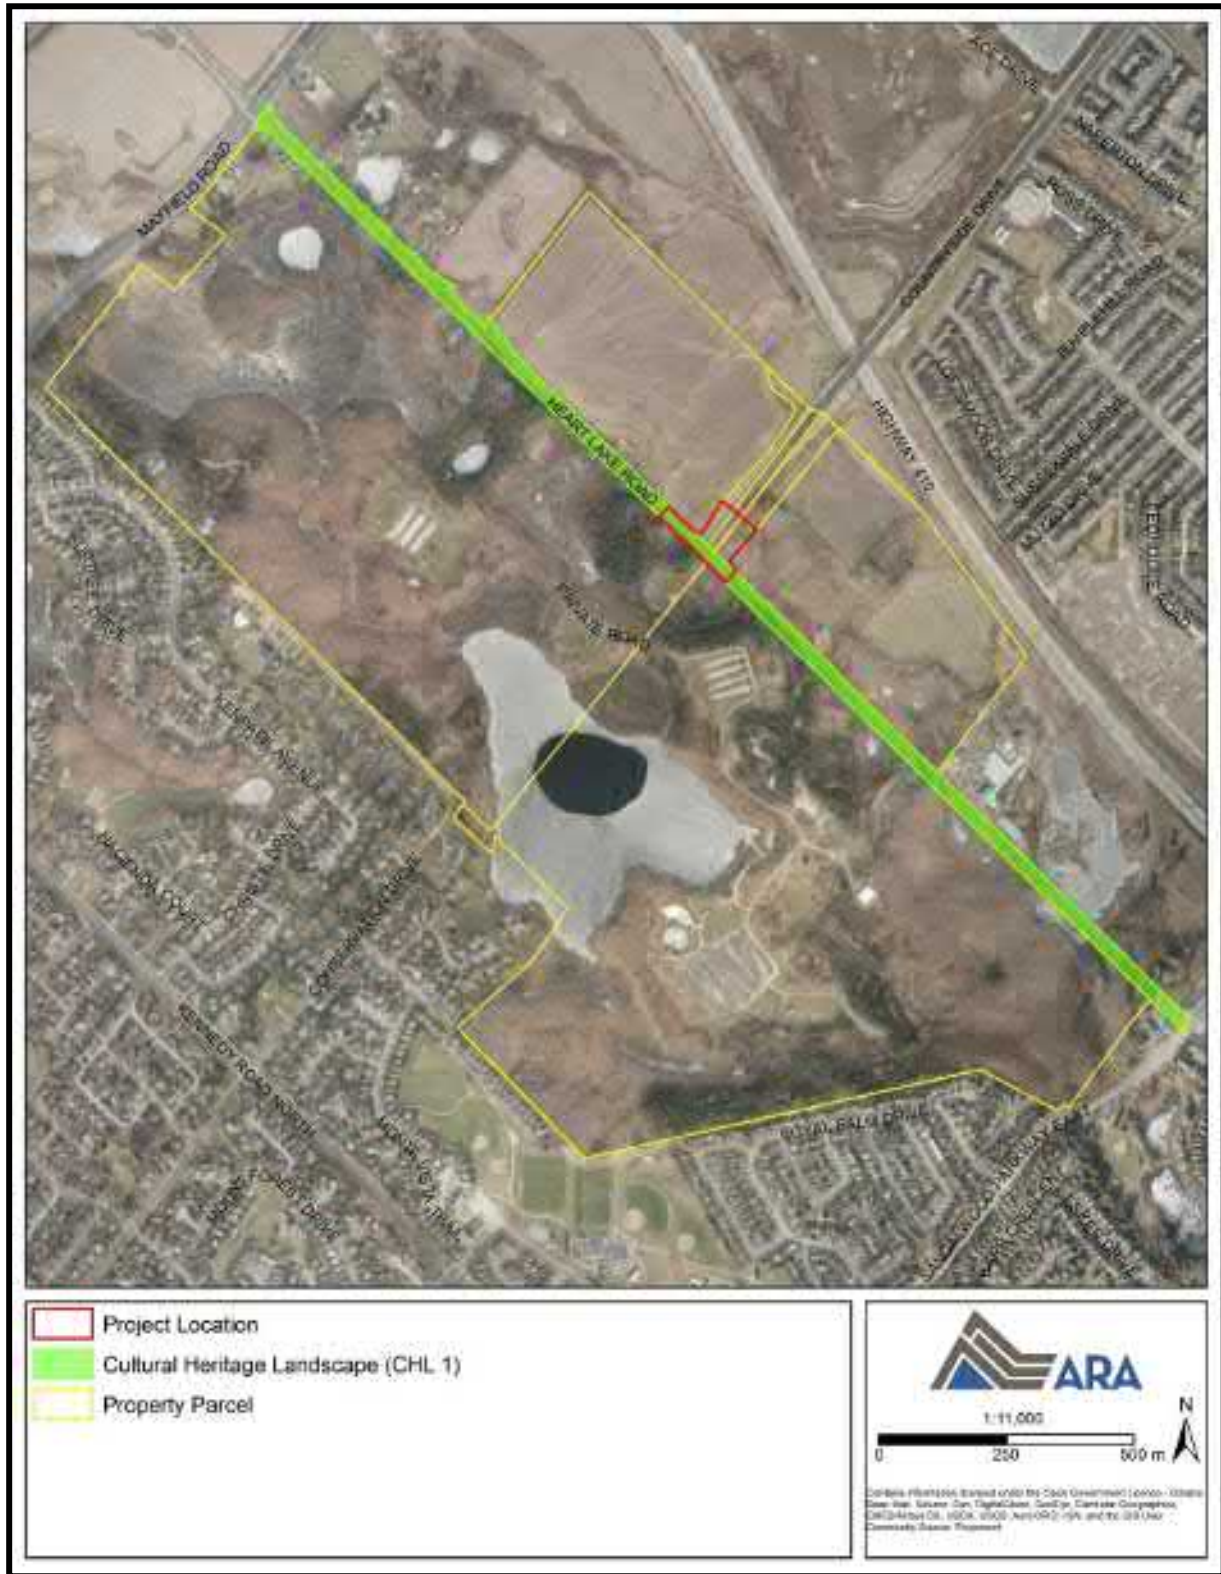
Map 9: CHL Assessment Results Map
(Produced by ARA under licence using ArcGIS® software by Esri, © Esri)

A summary of the results of the evaluation of the BHR and CHL against the criteria set out in O. Reg. 9/06 can be found in Table 3 and Table 4 and the information sheets with background information, and the evaluations of each heritage resource can be found in Appendix A. The assessment determined that BHR1 and CHL1 met one or more O. Reg. 9/06 criteria.

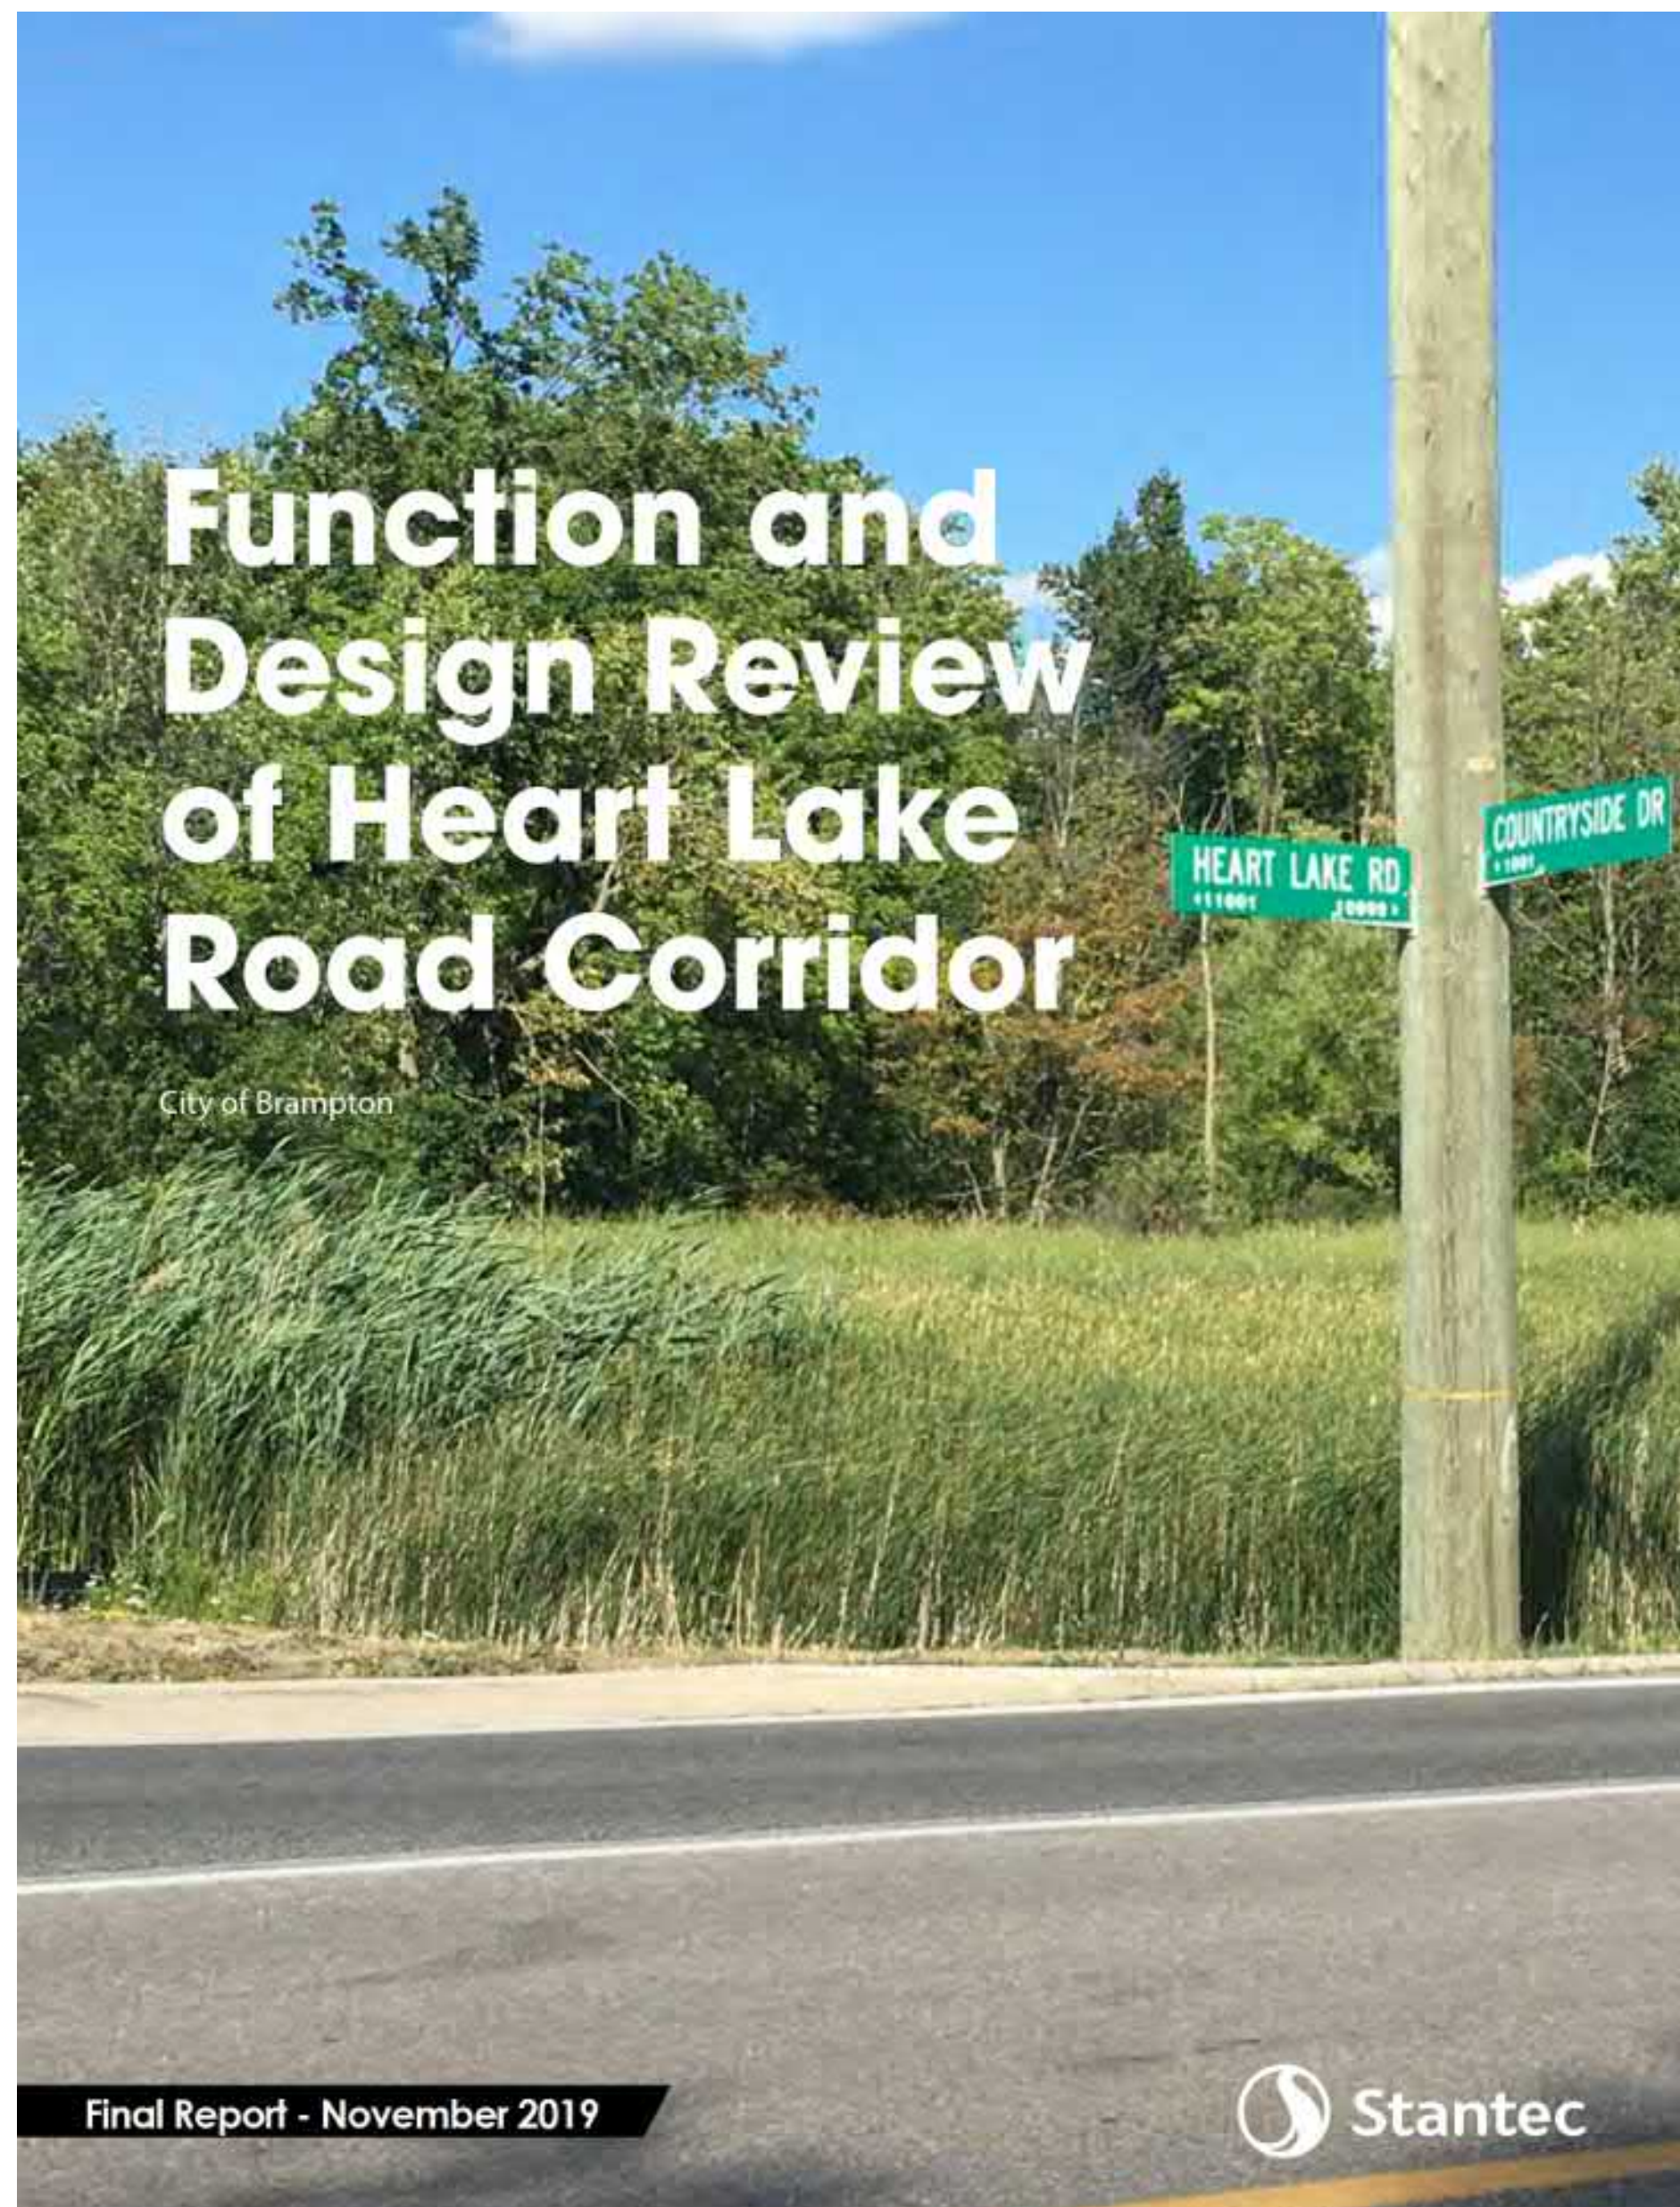
2019 Function and Design Review Study

Short-Term Recommendations

- Narrower lanes, hybrid multi-use trails through Heart Lake Conservation Area
- Reclassify as Collector Road, 50 km/h speed limit, speed cushions
- **Wildlife mortality:** Maintain flashers, maintain optical speed bars, additional eco-passages, wildlife directional fencing, turtle nesting mounds
- Maintain an enhance wildlife
