Presentation for Various Project Meetings

Heart Lake Rd. & Countryside Dr. Class EA

Technical Advisory Committee (TAC) Meeting November 21, 2021

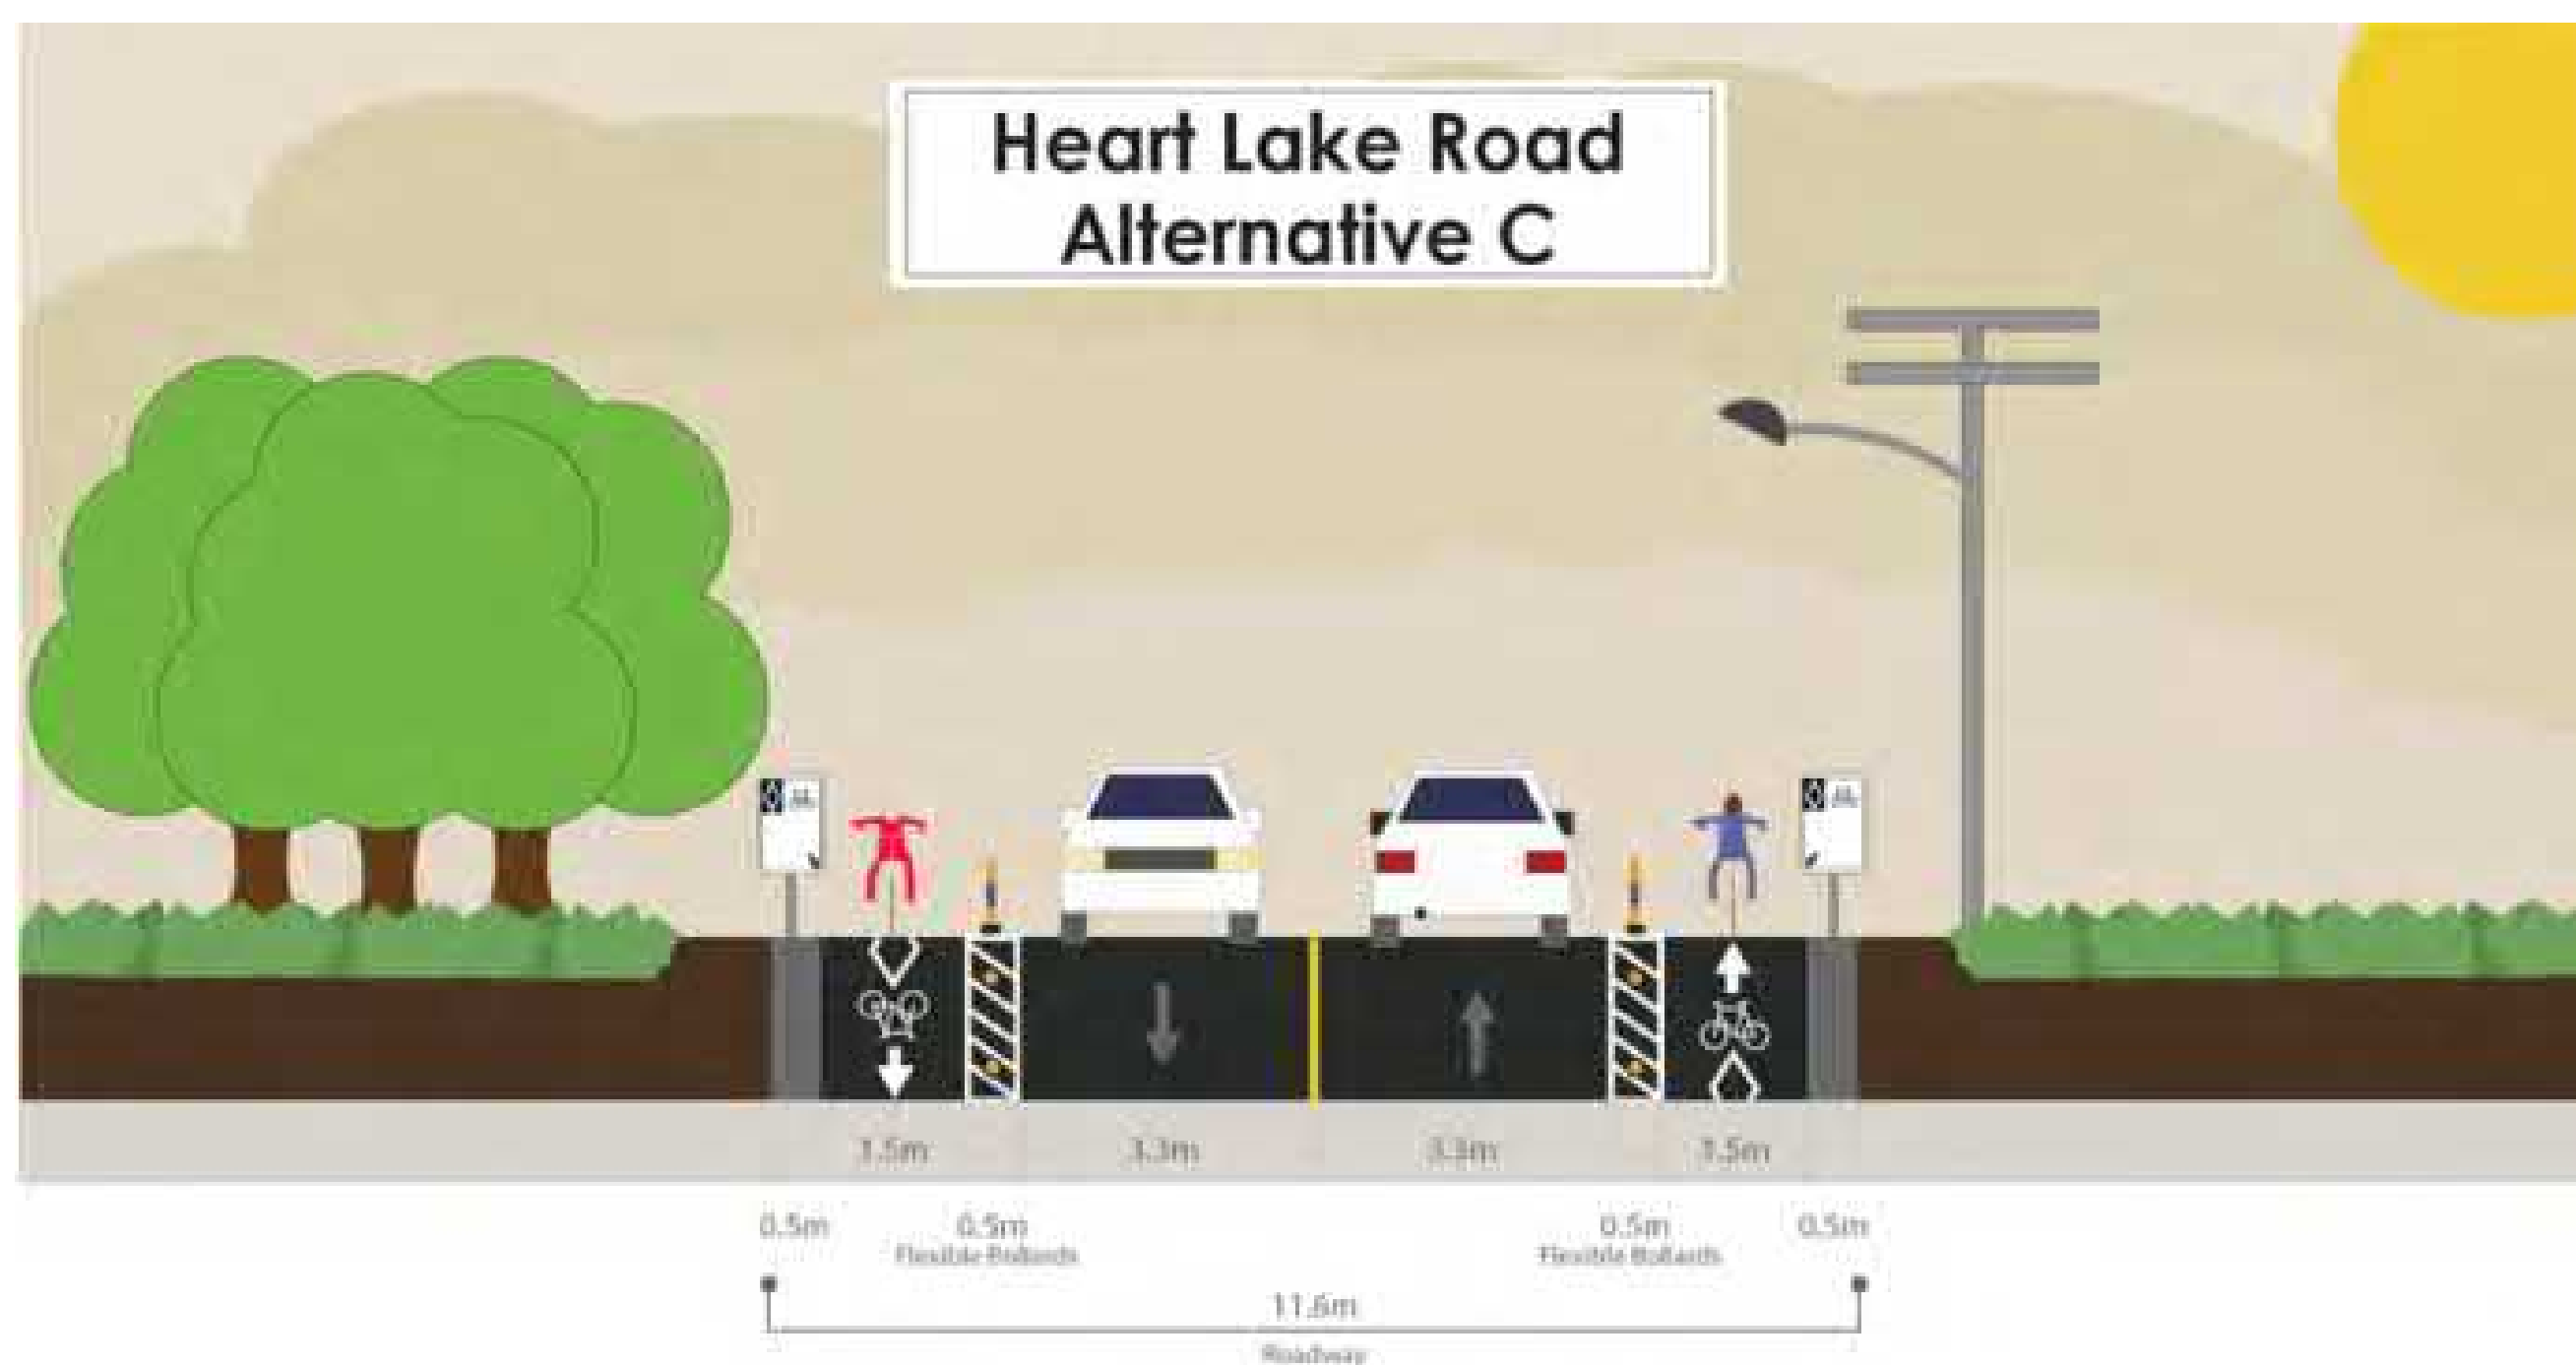
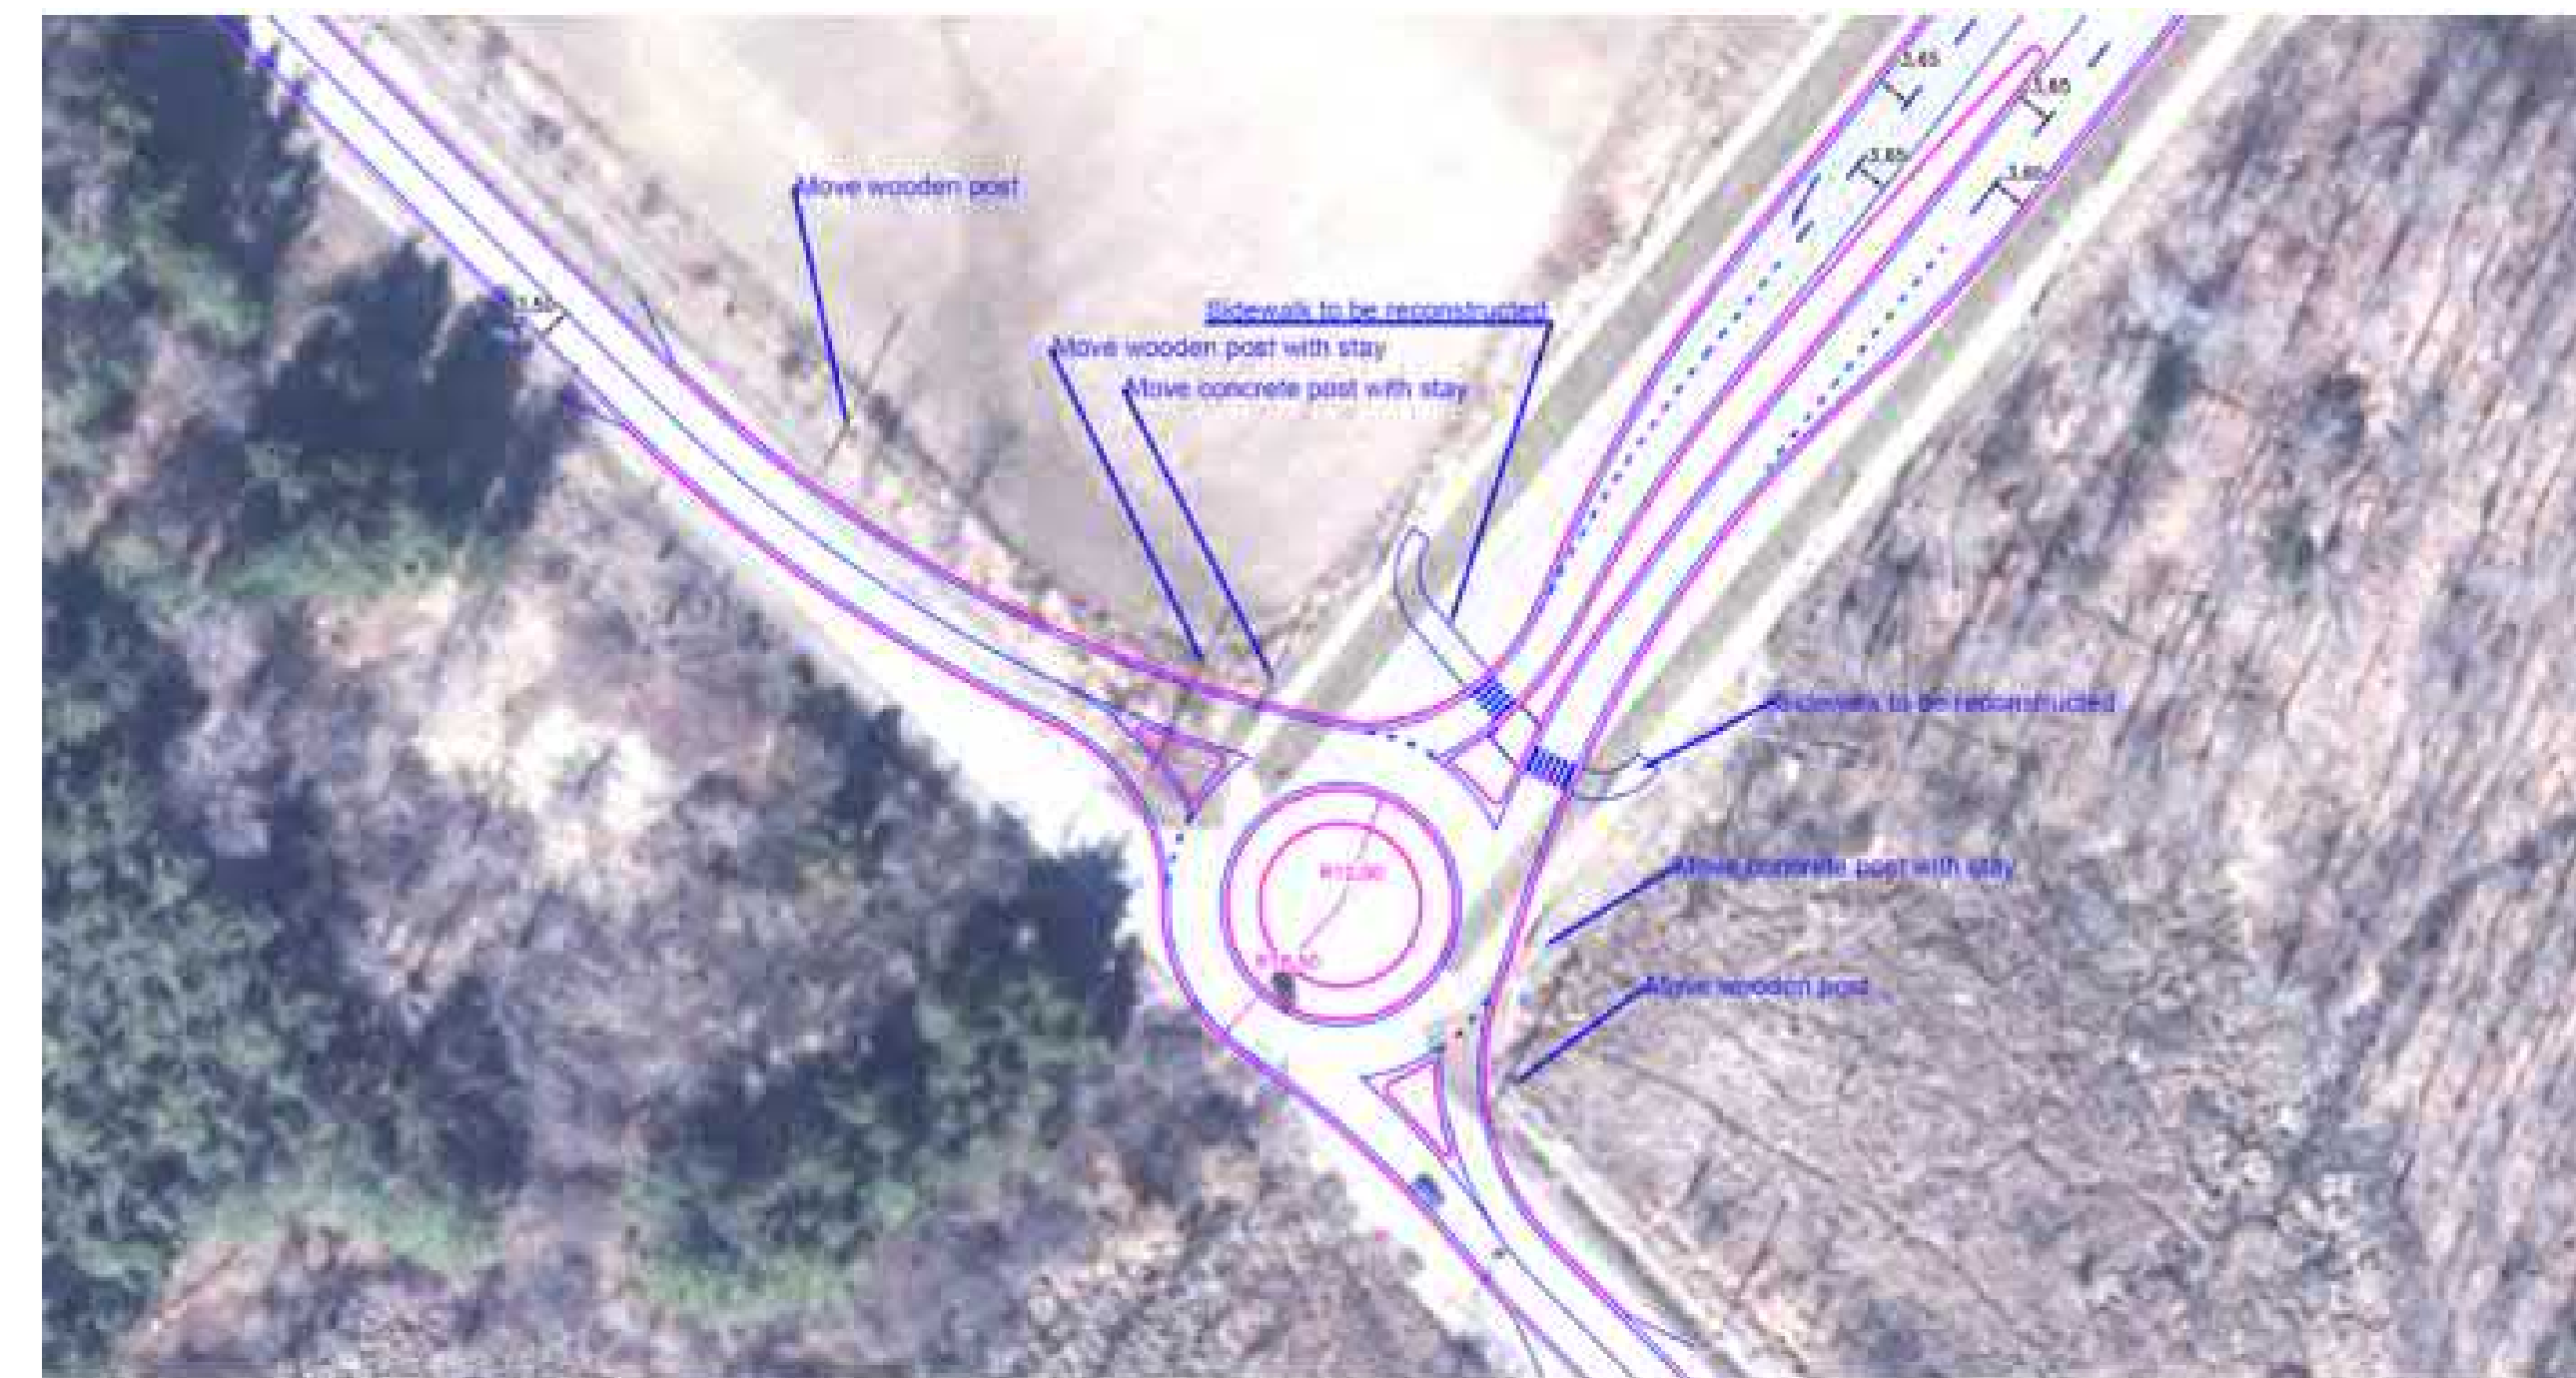
Figure 50: Roundabout at Countryside Option 2 (without encroachment on TRCA lands)

- Separated bike lanes on Heart Lake Rd. & Roundabout at Countryside

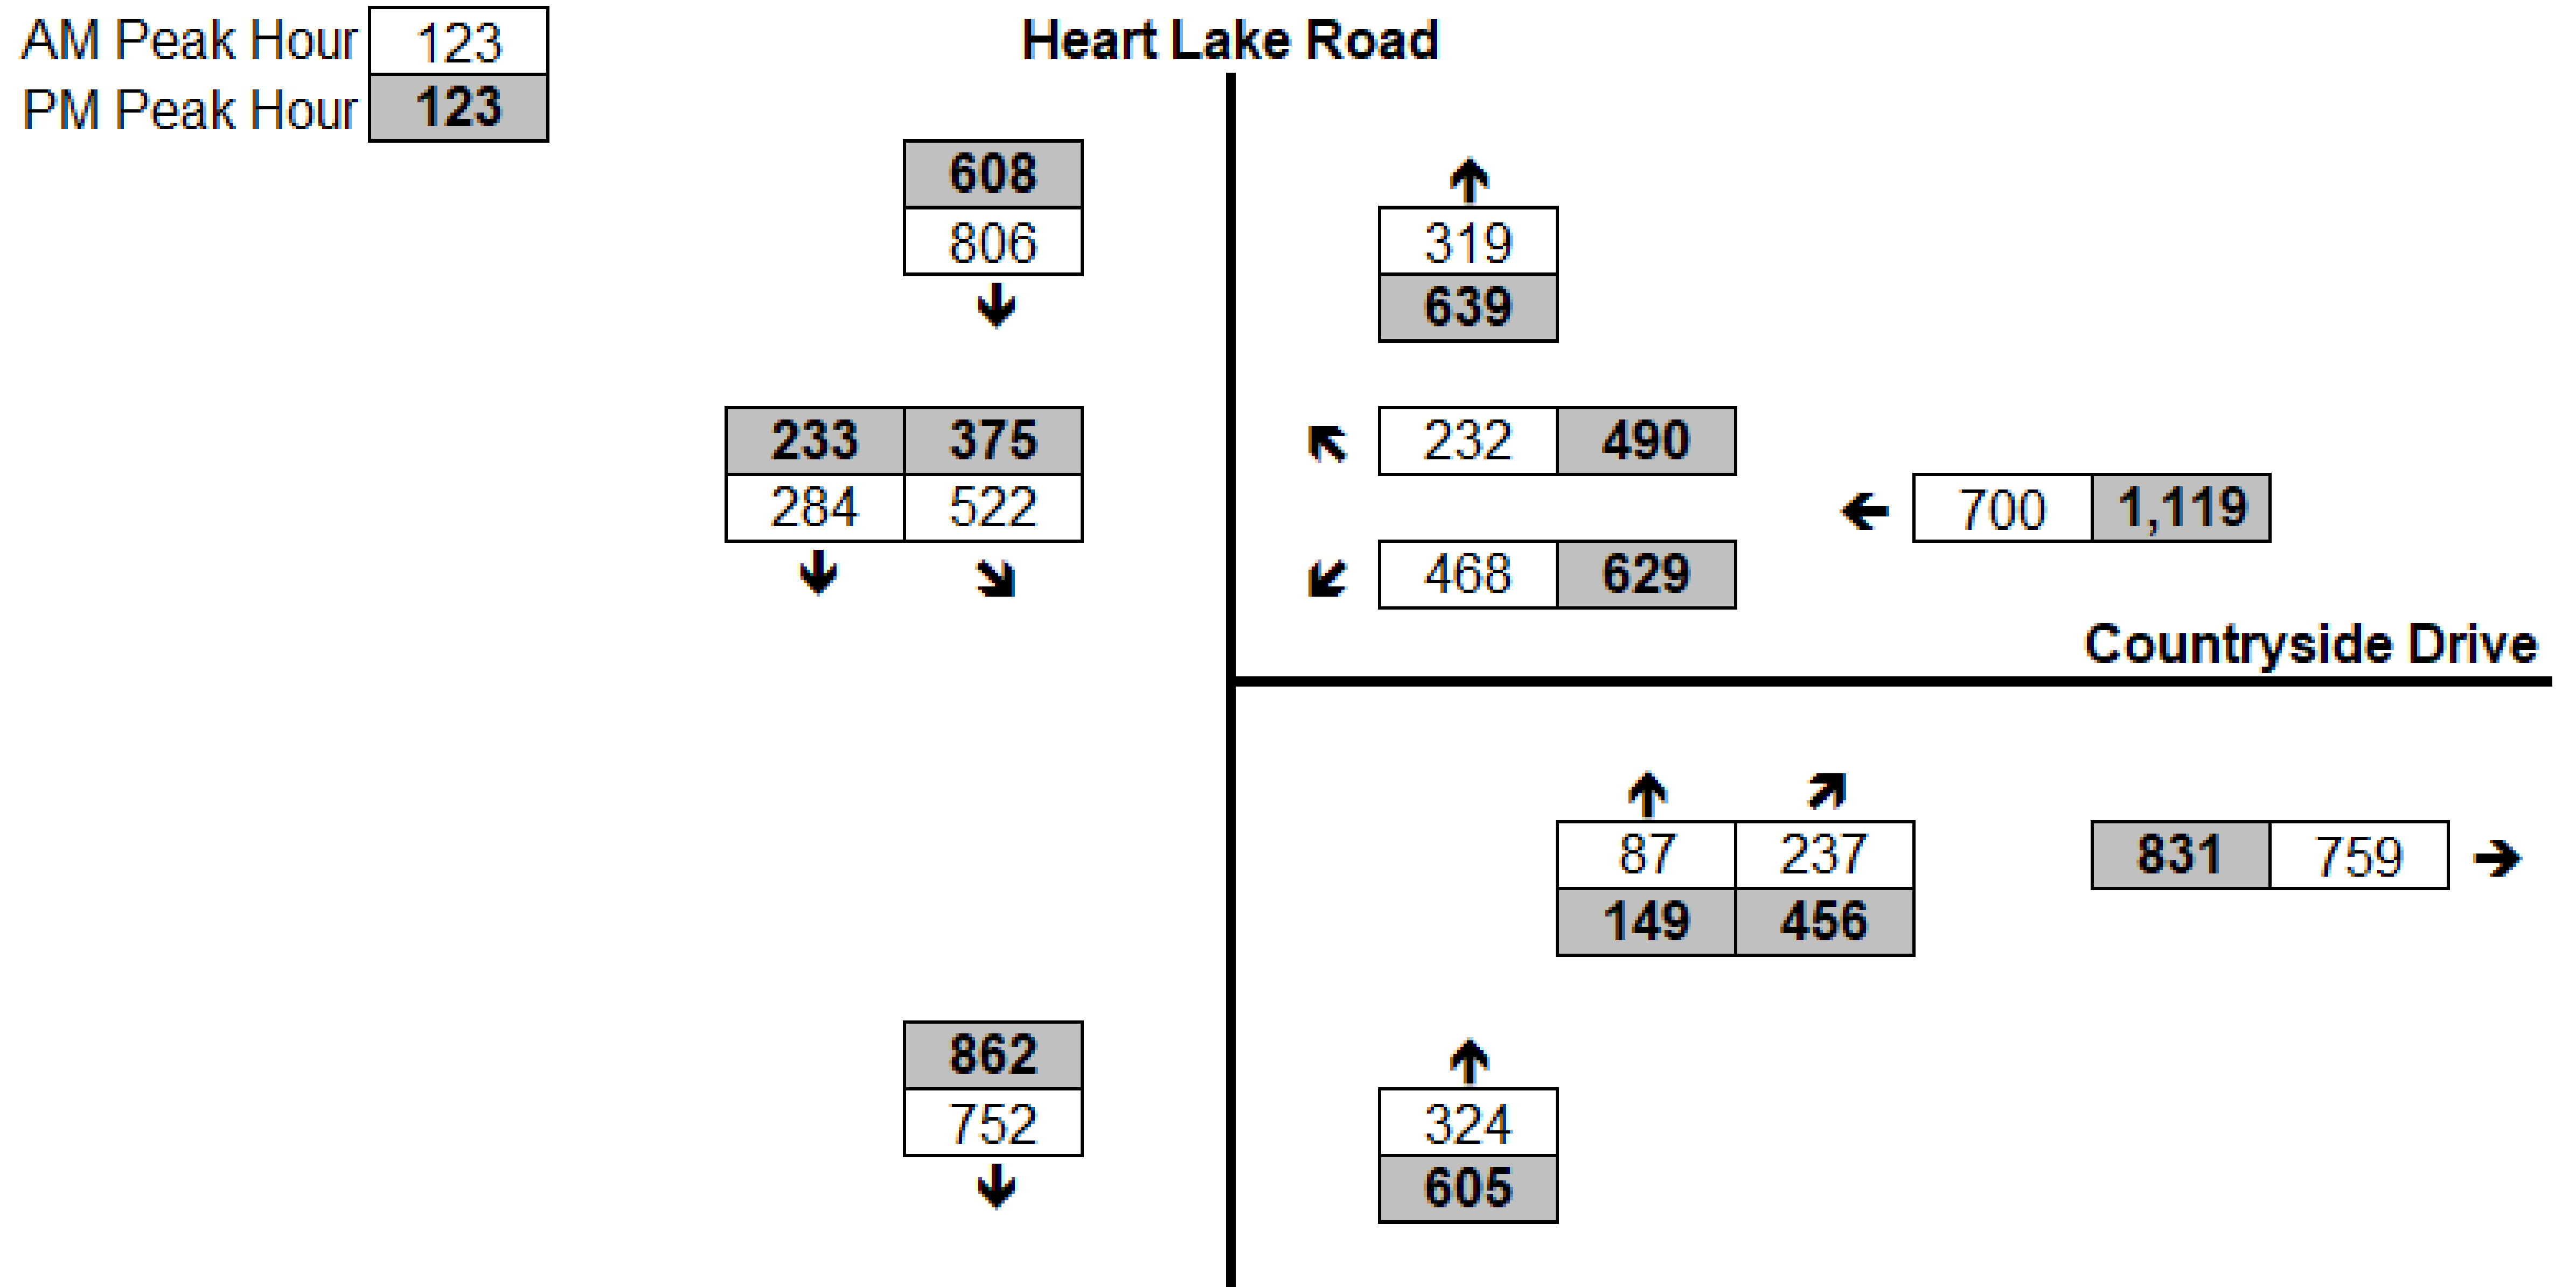
2041 Traffic Volumes

Traffic forecasts were developed via the application of calculated growth rates

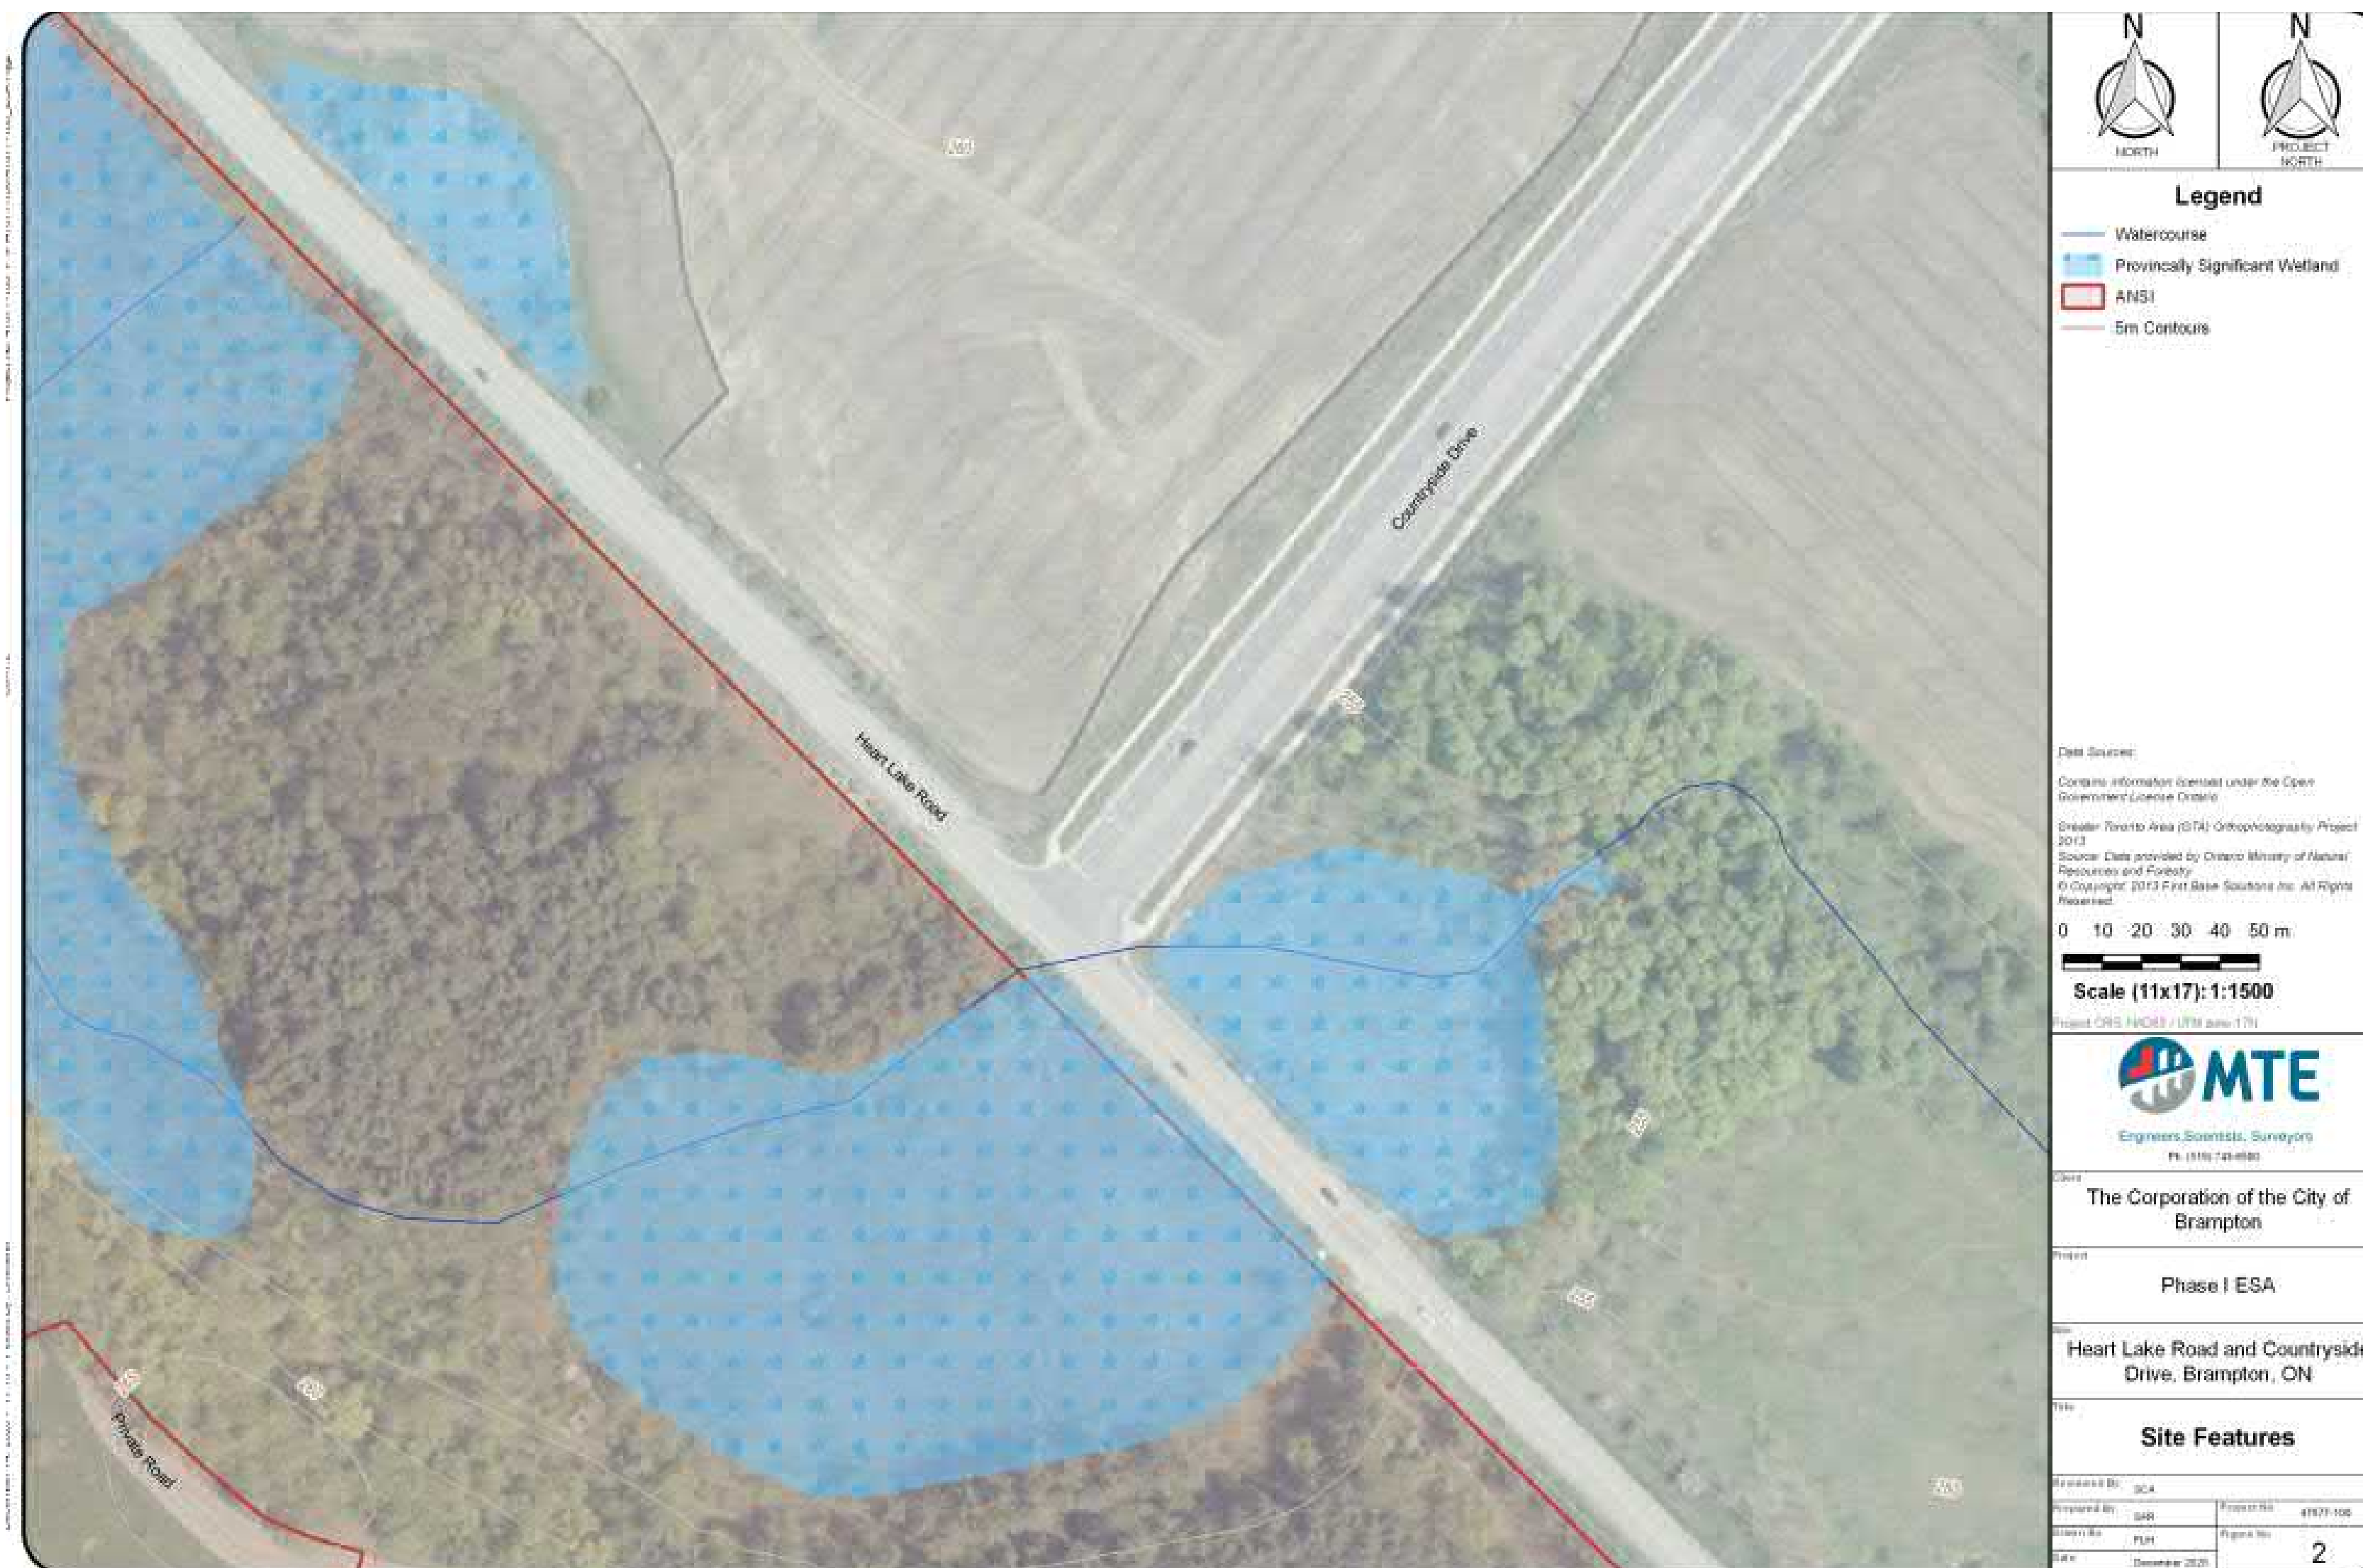
Phase 1 Environmental Site Assessment

- No records of spills
- Fill has been added over the years
- Additional testing should be undertaken prior to construction

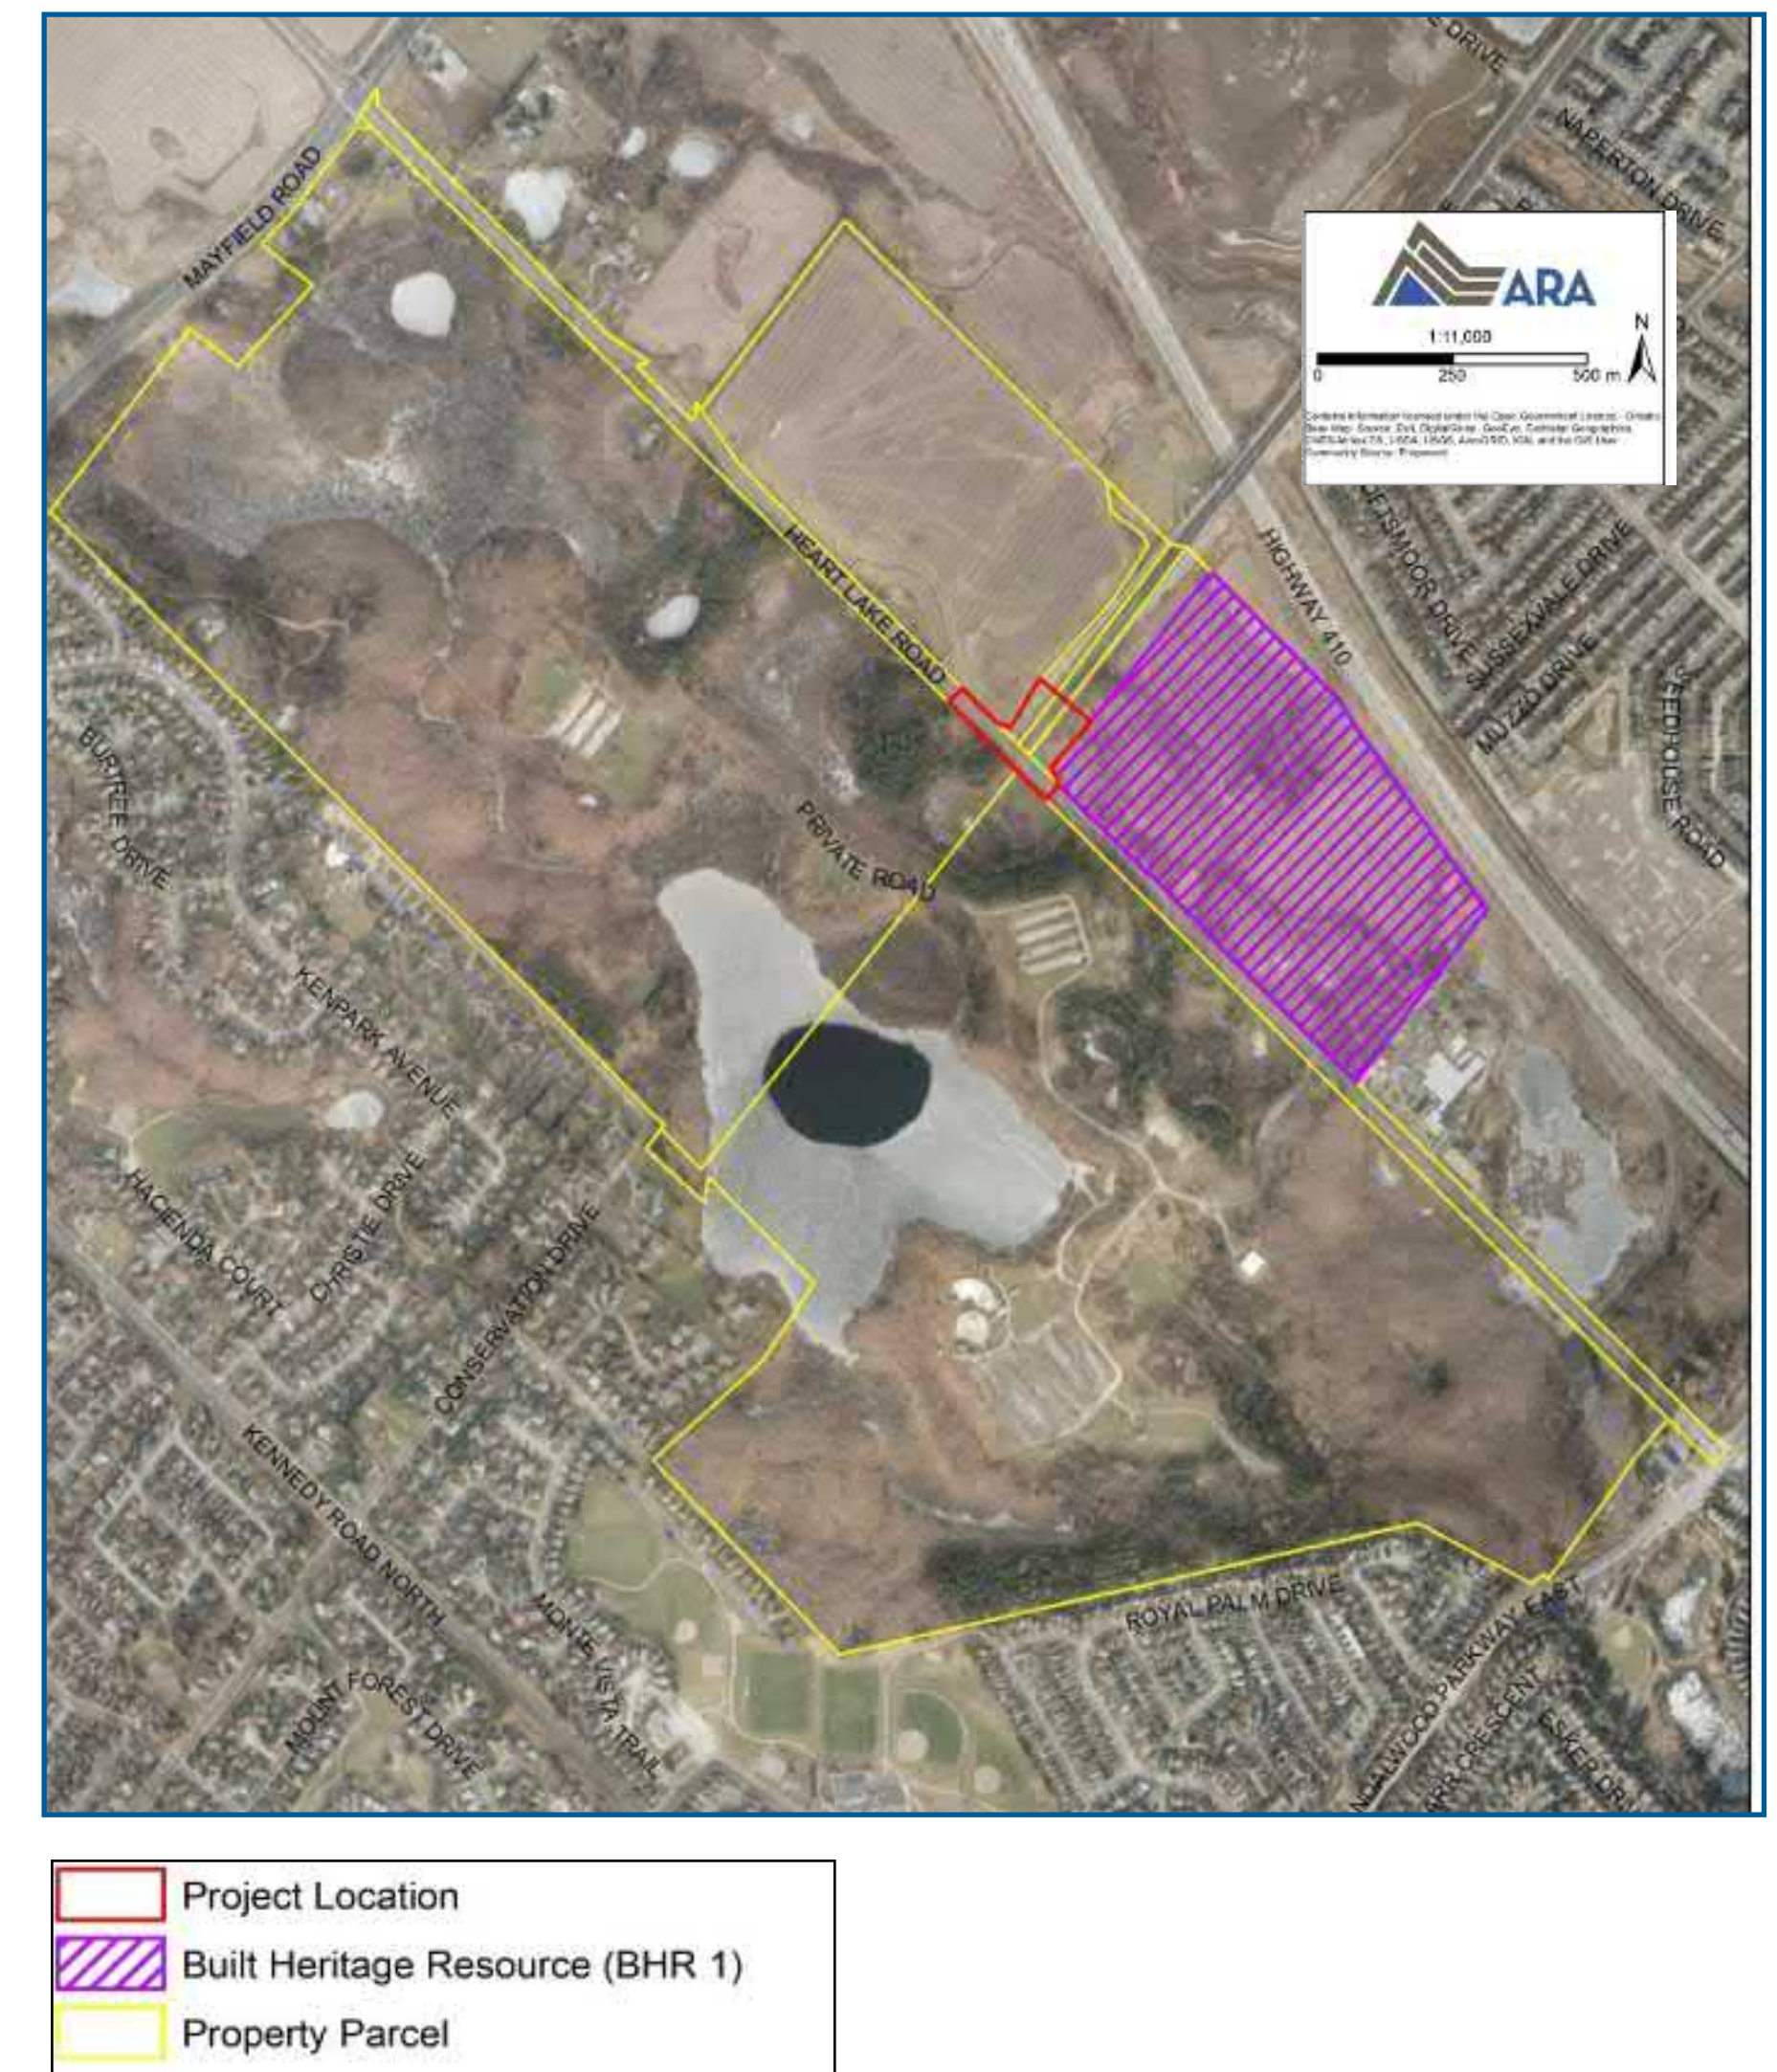
Built/ Cultural Heritage Assessment

- Wetland is considered a Built Heritage Resource
- Heart Lake Road is considered a Cultural Heritage Landmark
